**Livingston County
Water and Sewer Authority**

**Leicester/York Regional Water Supply
Expansion
Engineering Report Amendment #1**

March 2024

County of Livingston
1 Court Street, Rm B02
Geneseo, NY 14454
RE: 6 Murray Drive
350,000 Gallon EWT
March 4, 2016 & April 12, 2016
Mr. John Driscoll
S.C.S.
(585) 243-7505
Job No. 316029

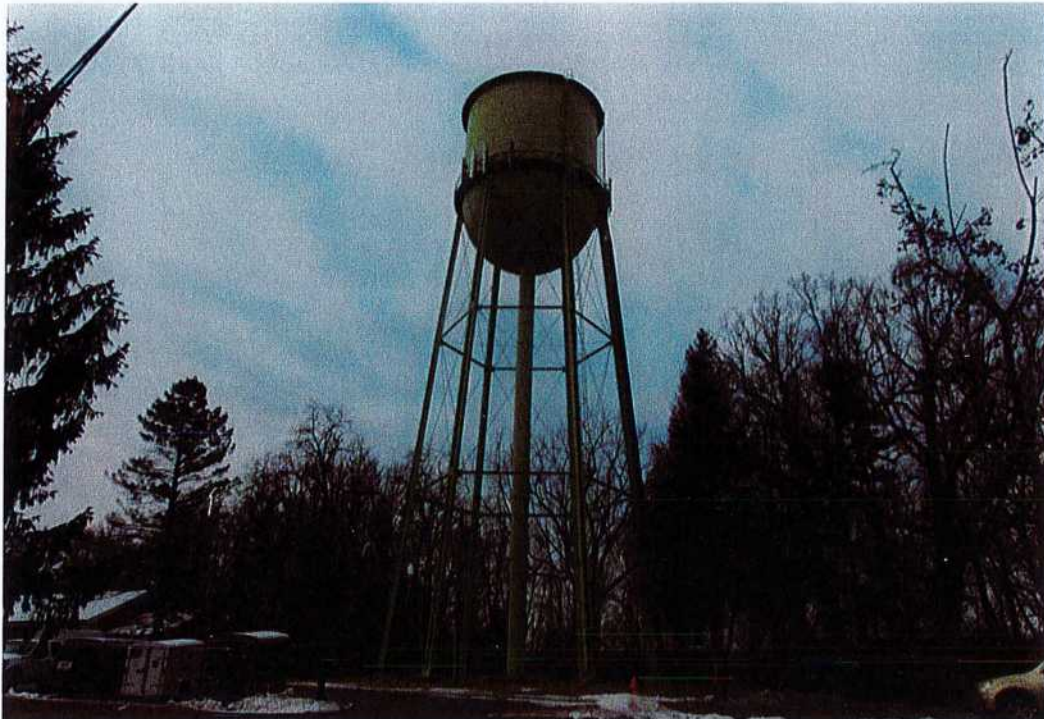
Photo shows the tank is not secured with fencing. We recommend fencing the area around the tank. We further recommend posting a **No Trespassing** sign and a **Warning, Tampering With This Facility is a Federal Offense (US code title 42, section 300i-1)** sign. Fence installation to be done by others.

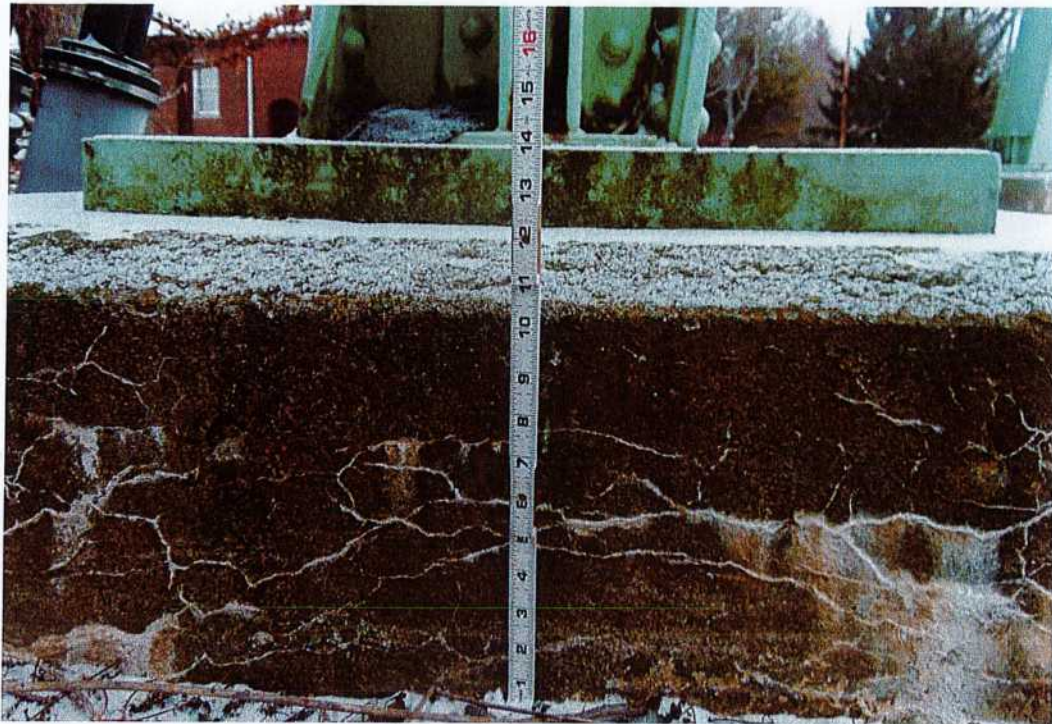
Photo shows the condition of the foundations, which meet the height requirements of [AWWA D100-11; 12.7.1: Foundations](#).

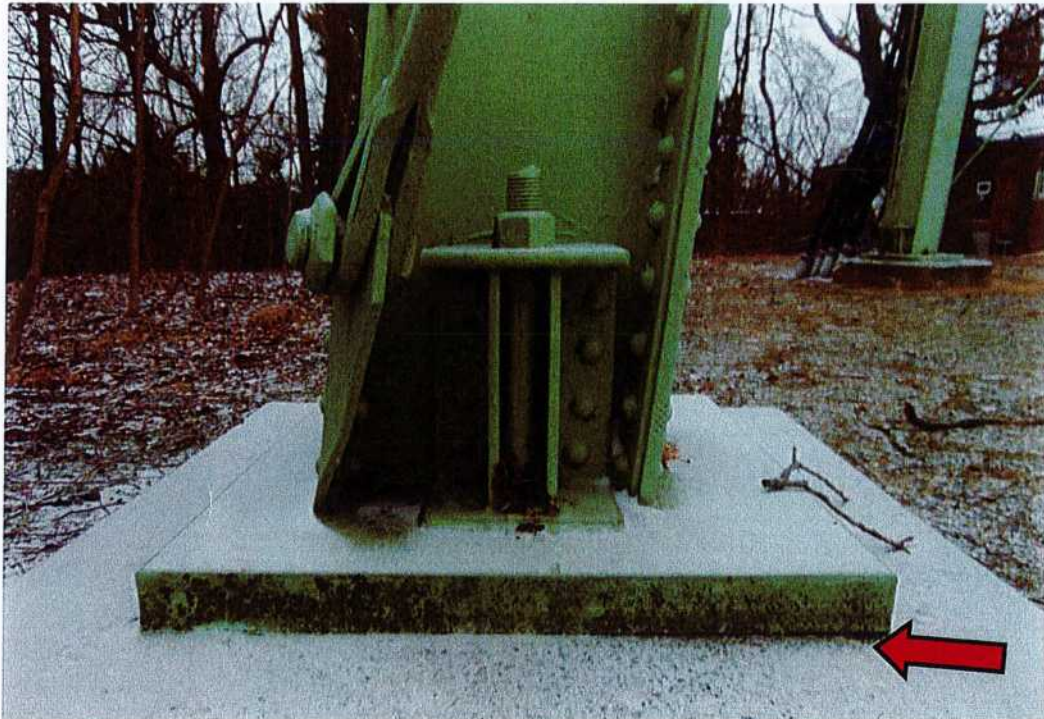
Photo shows the condition of the foundations. We recommend caulking around the base of the tank foundation connections to prevent water from entering.

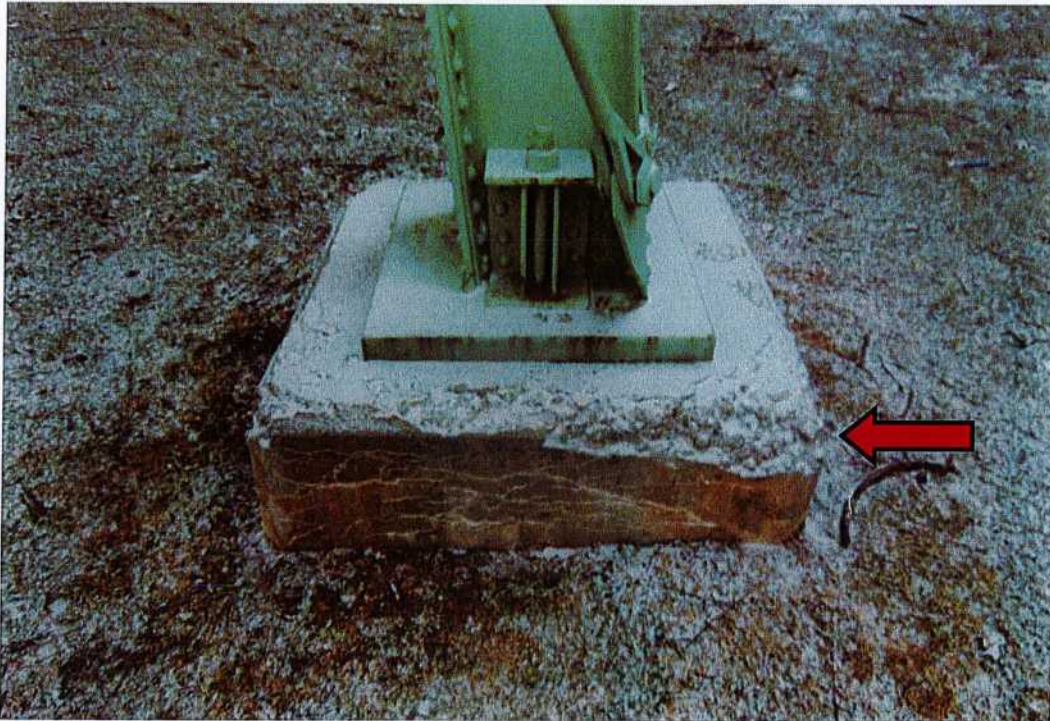
Photo shows the condition of the foundations. We recommend removing all dirt, debris and loose gravel from the foundations, repairing any cracks and spalling in the concrete with a commercial non-shrinking grout and sealing the foundations with a sealant.

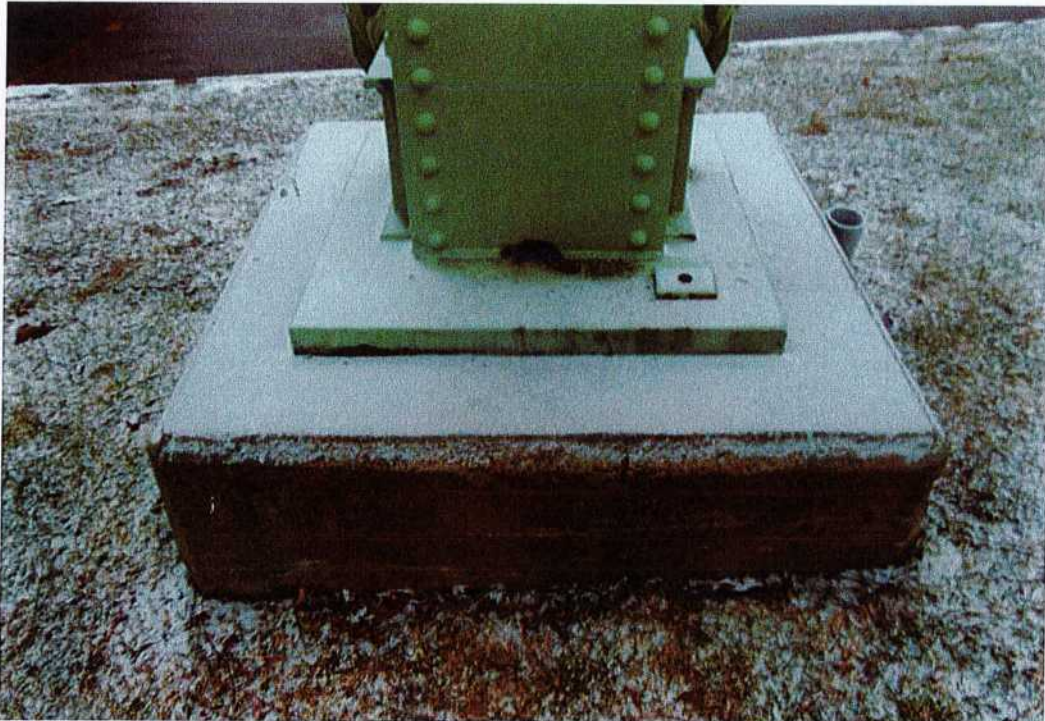
Photo shows more of the tank foundation. We recommend electrically grounding the tank for lightning protection as required by [OSHA Act 29 CFR 1926 \(K\)](#).

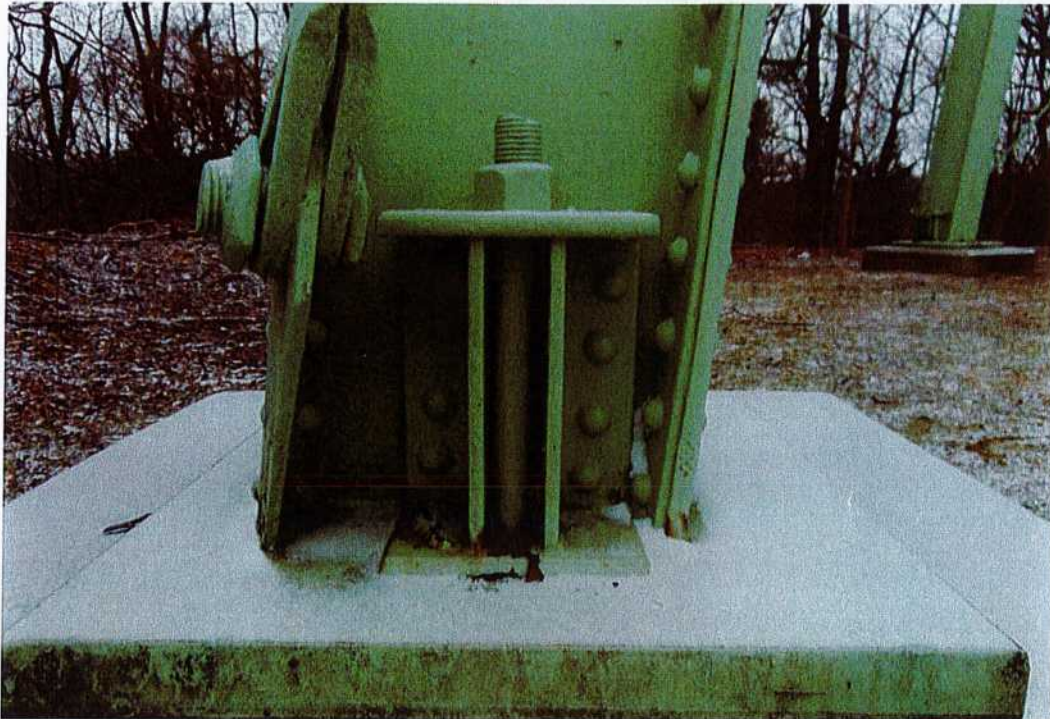
Photo shows the condition of the anchor bolts. The structural integrity of the anchor bolts should be maintained to withstand 100 mph winds blowing from any direction as required by **AWWA D100-11; 3.8: Anchorage**. We recommend cleaning the area around the anchor bolts, tightening the anchor bolt nuts to specifications and welding around the circumference of the bolt-to-nut and nut-to-base plate connections to reinforce.

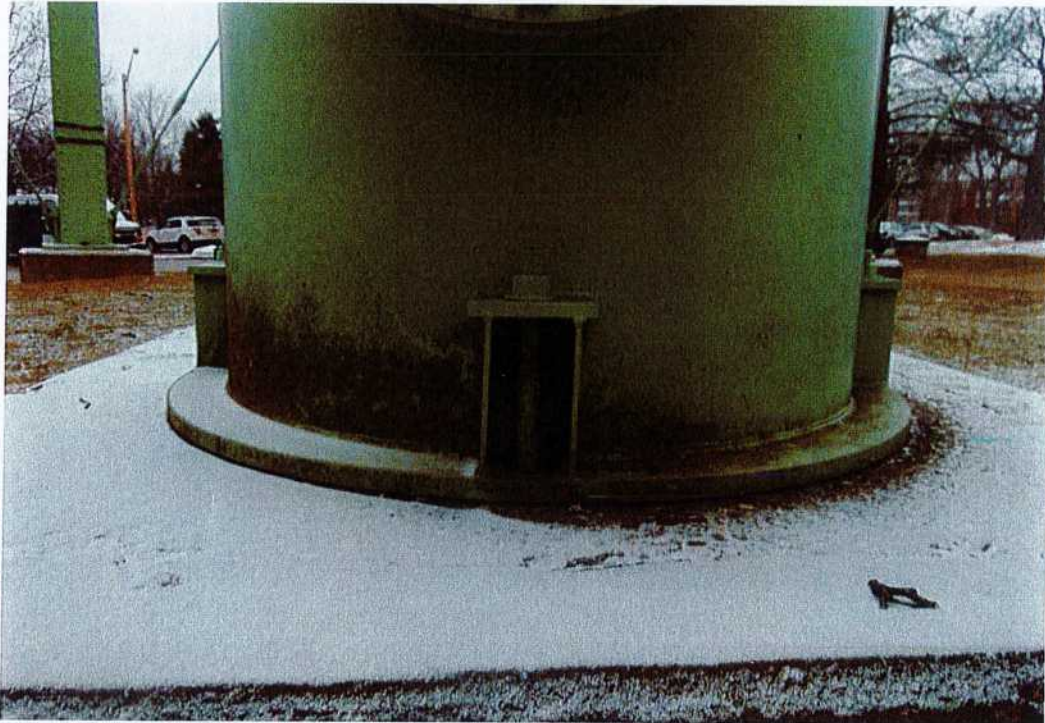
Photo shows the base of the riser pipe. Currently there is no riser drain valve. A drain valve performs two functions; it allows the tank to be drained and it is used as a blowout to remove silt and scale from the lower portion of the tank. We recommend installing a frost proof drain valve, complete with locking device to prevent unauthorized draining of the tank and a splash pad to direct water away from the foundation.

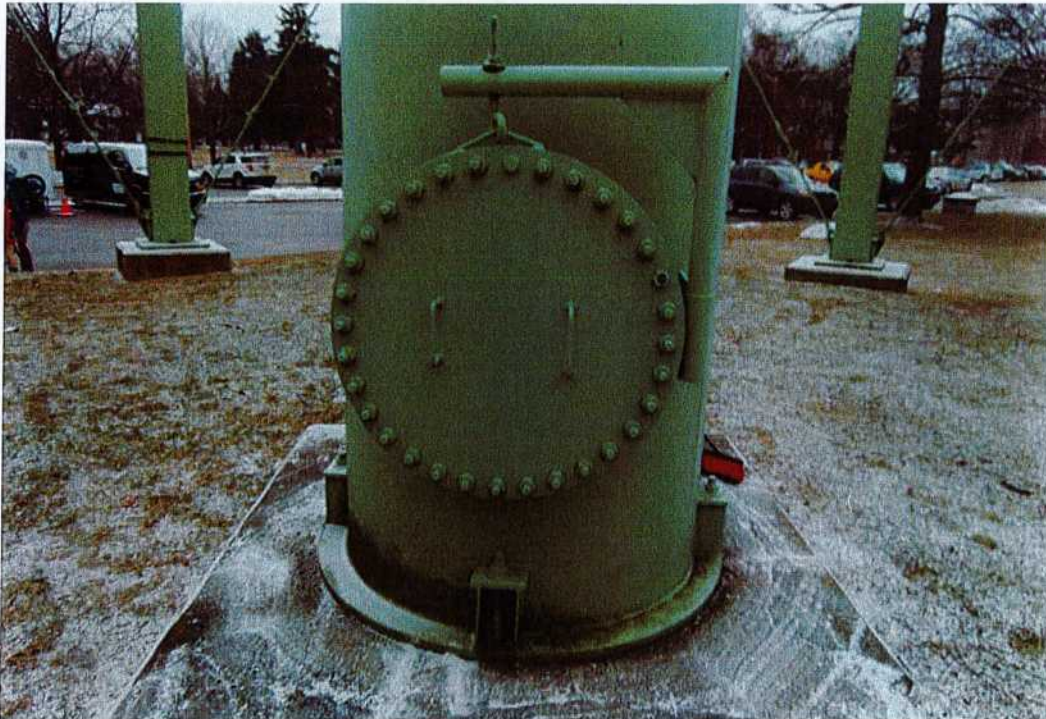
Photo shows the condition of the 24" riser manway. This manway meets the size requirements for **AWWA D100-11: 5.4.4**. We recommend posting a **Confined Space Entry** sign and installing maintenance free galvanized steel bolts.

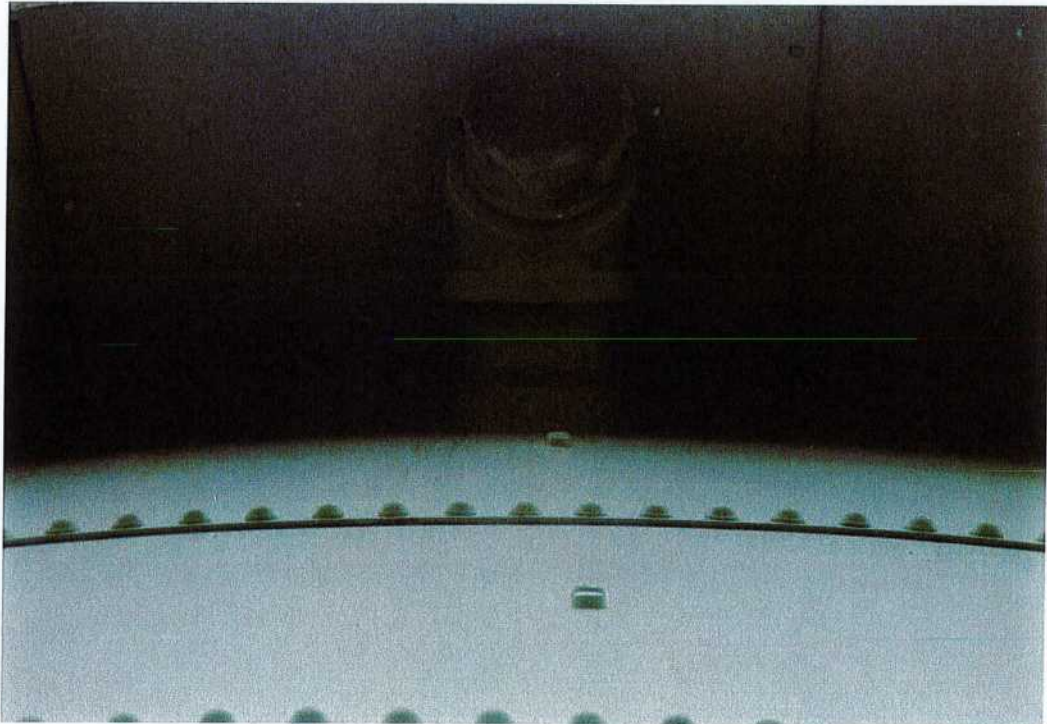
Photo shows the condition of the stub overflow pipe. The overflow pipe is not equipped with a flapper valve. We recommend extending the overflow down the exterior to grade with the same sized pipe, complete with standoffs every 10' on center, an elbow at the base fitted with a flapper valve and screen to prevent the ingress of contaminants into the water supply and a splash pad to direct water away from the foundation.

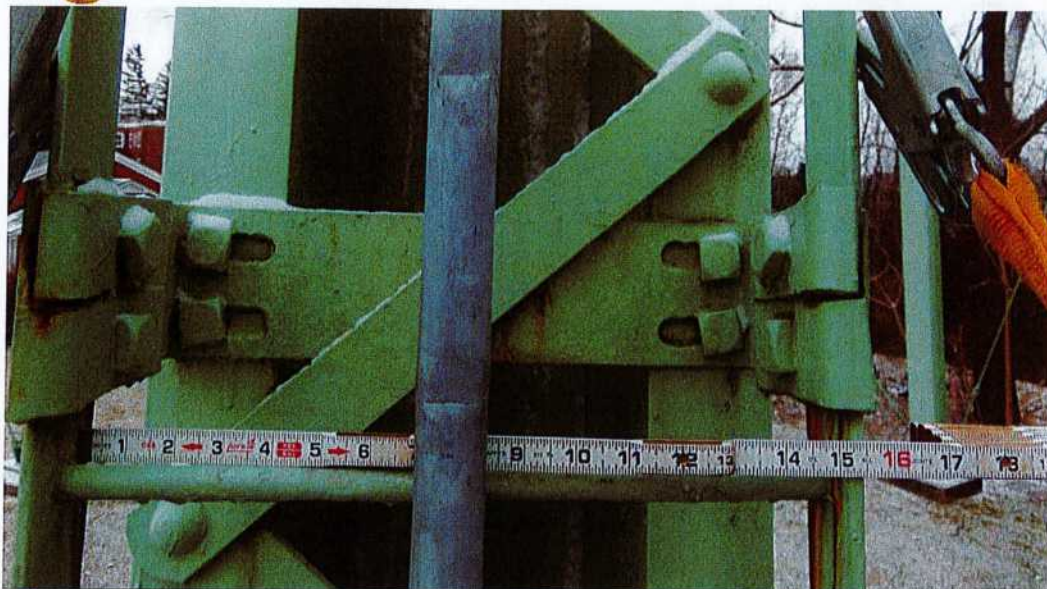
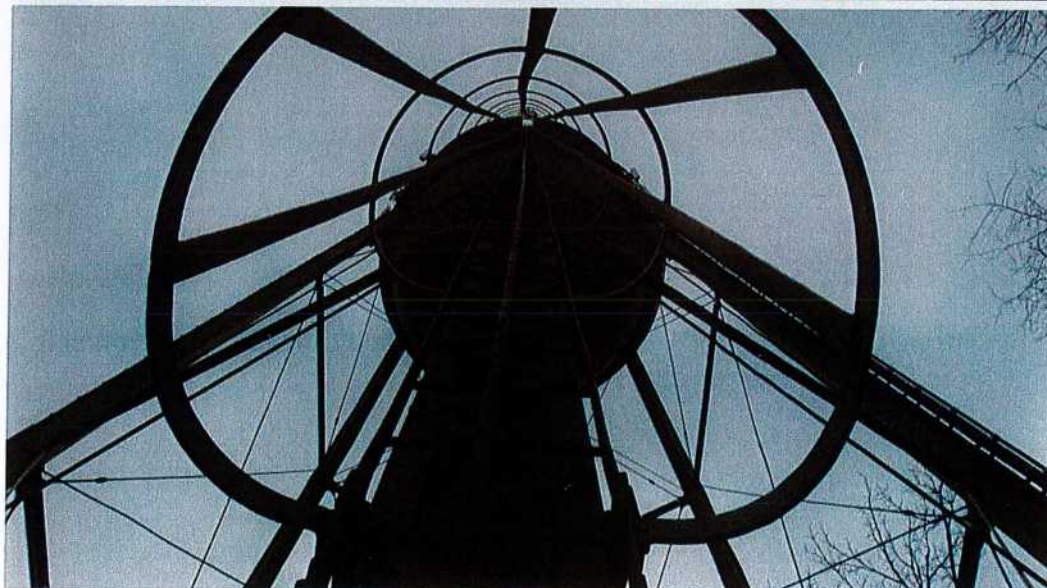
Tower access ladder in above photos is not equipped with anti-skid rungs and is 15" wide. **Notice the notched rail safety slide.** **OSHA 1910.27 Ladders** states, "Minimum clear distance between the sides of individual rung/step ladders and between the side rails of other fixed ladders must be 16" (41 cm)." **OSHA 1910.27** states, "Rungs-must be corrugated, knurled, dimpled, coated with skid-resistant material or treated to minimize slipping." We recommend installing a compliant tower access ladder complete with standoffs every 10' on center, a cable type ladder safety device, a lockable ladder guard to prevent unauthorized access and posting a **Fall Protection Required** sign.

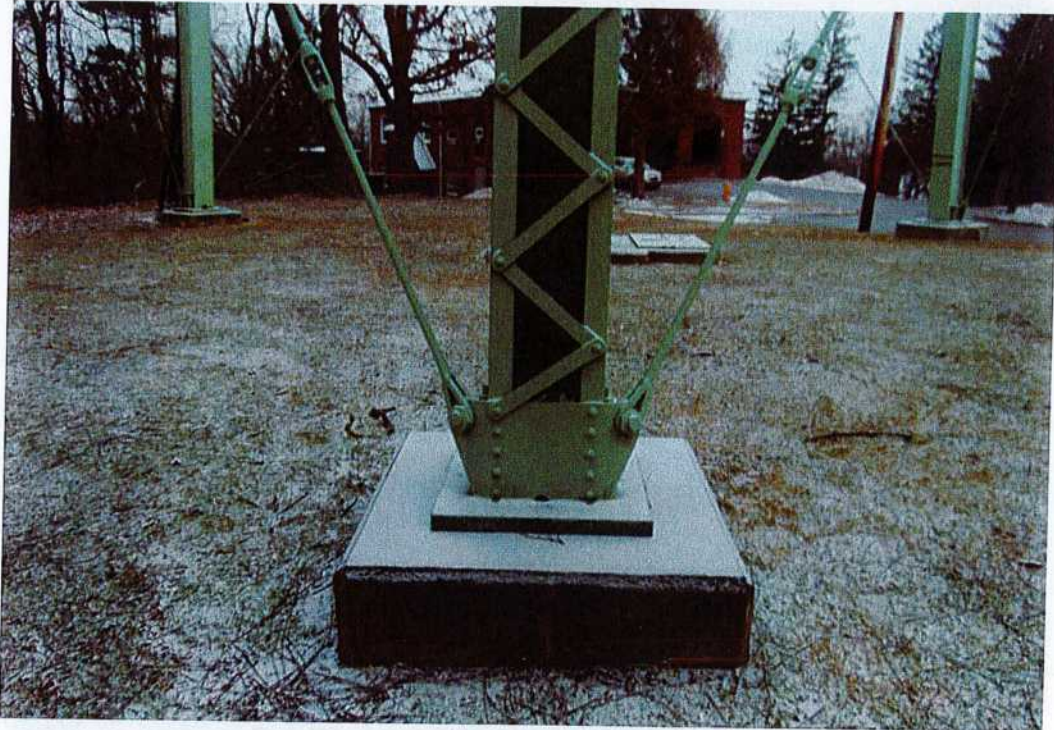
Photo shows the lattice legs. We recommend installing climbing guards on all legs to prevent unauthorized access.

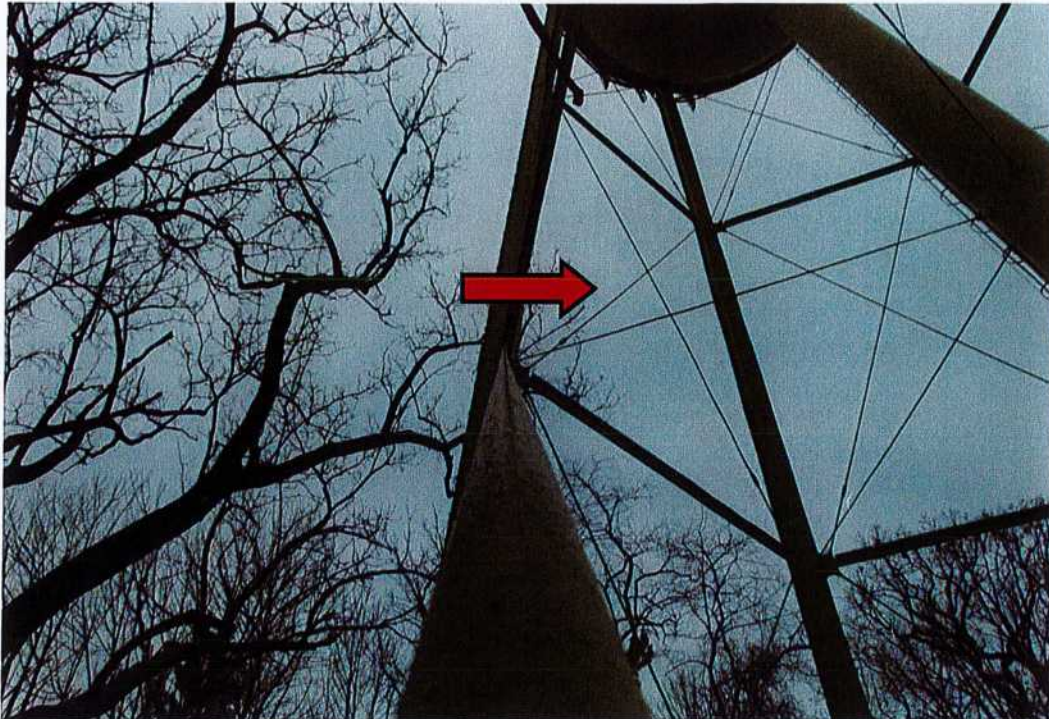
Photo shows the condition of the windage rods. The windage rods are designed to resist and stabilize the tower structure against wind and seismic loads combined with dead and live loads. The rods should withstand 100 mph winds blowing from any direction. **If the bracing remains loose, a sudden collapse could occur.** We recommend adjusting the windage rods as needed, to withstand 100 mph winds blowing from any direction, as required by [AWWA D100-11; 3.1.4.](#)

This work should be performed on an emergency basis.

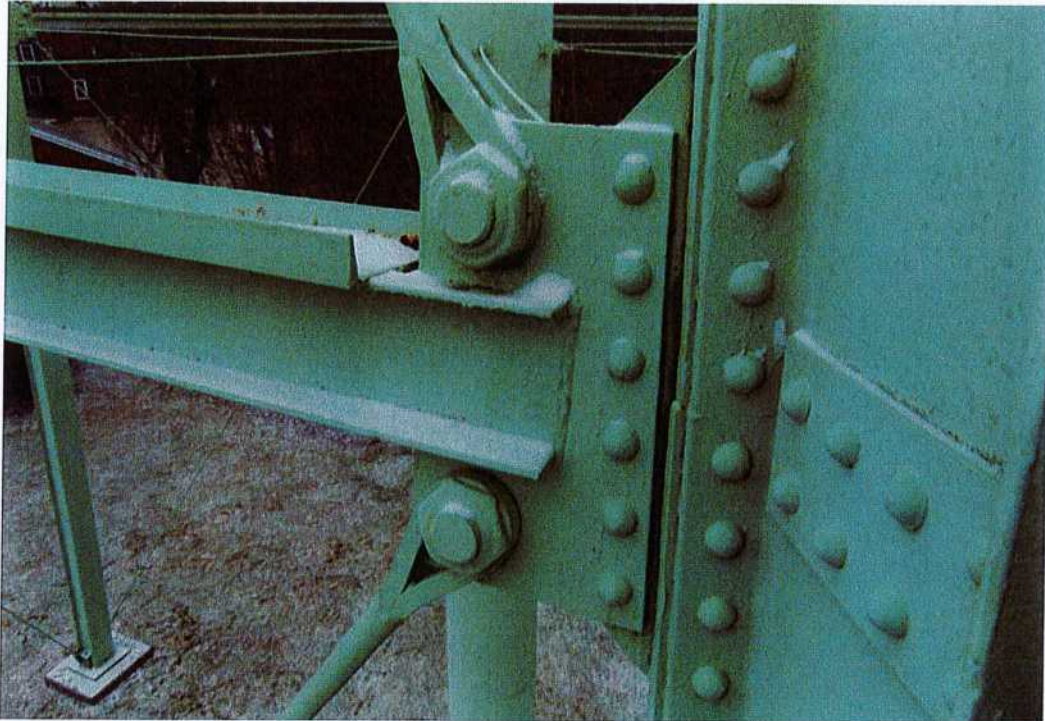
Photo shows the condition of the strut end connections. The strut ends appear to be in good condition.

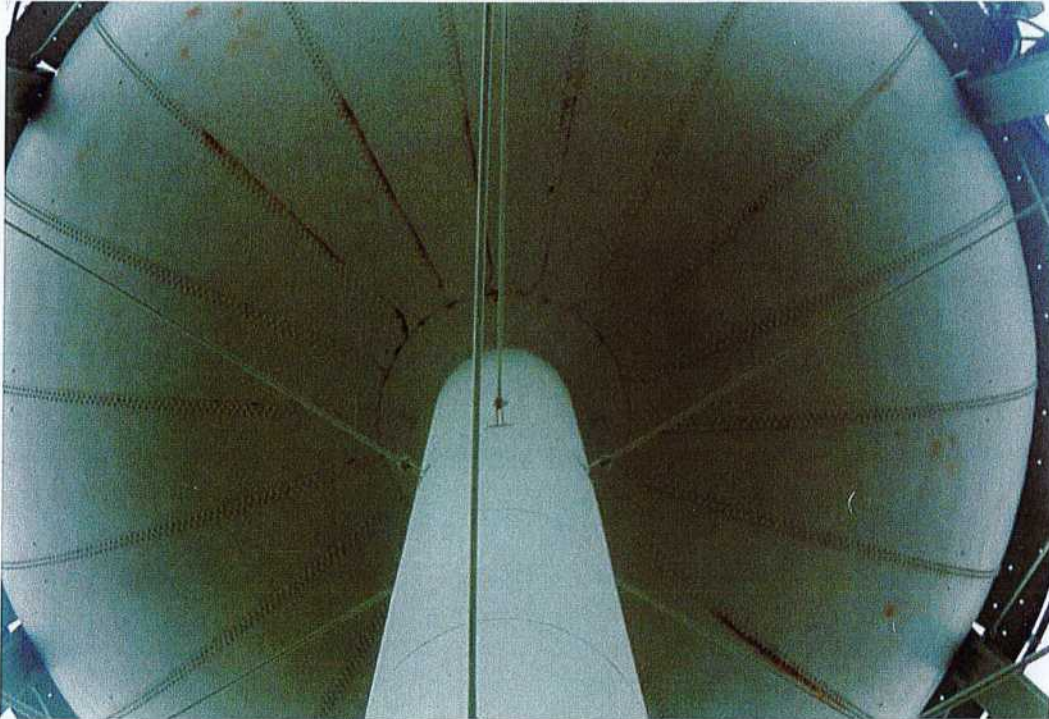
Photo shows the condition of the riser pipe and bowl connection, which appears to be in good condition.

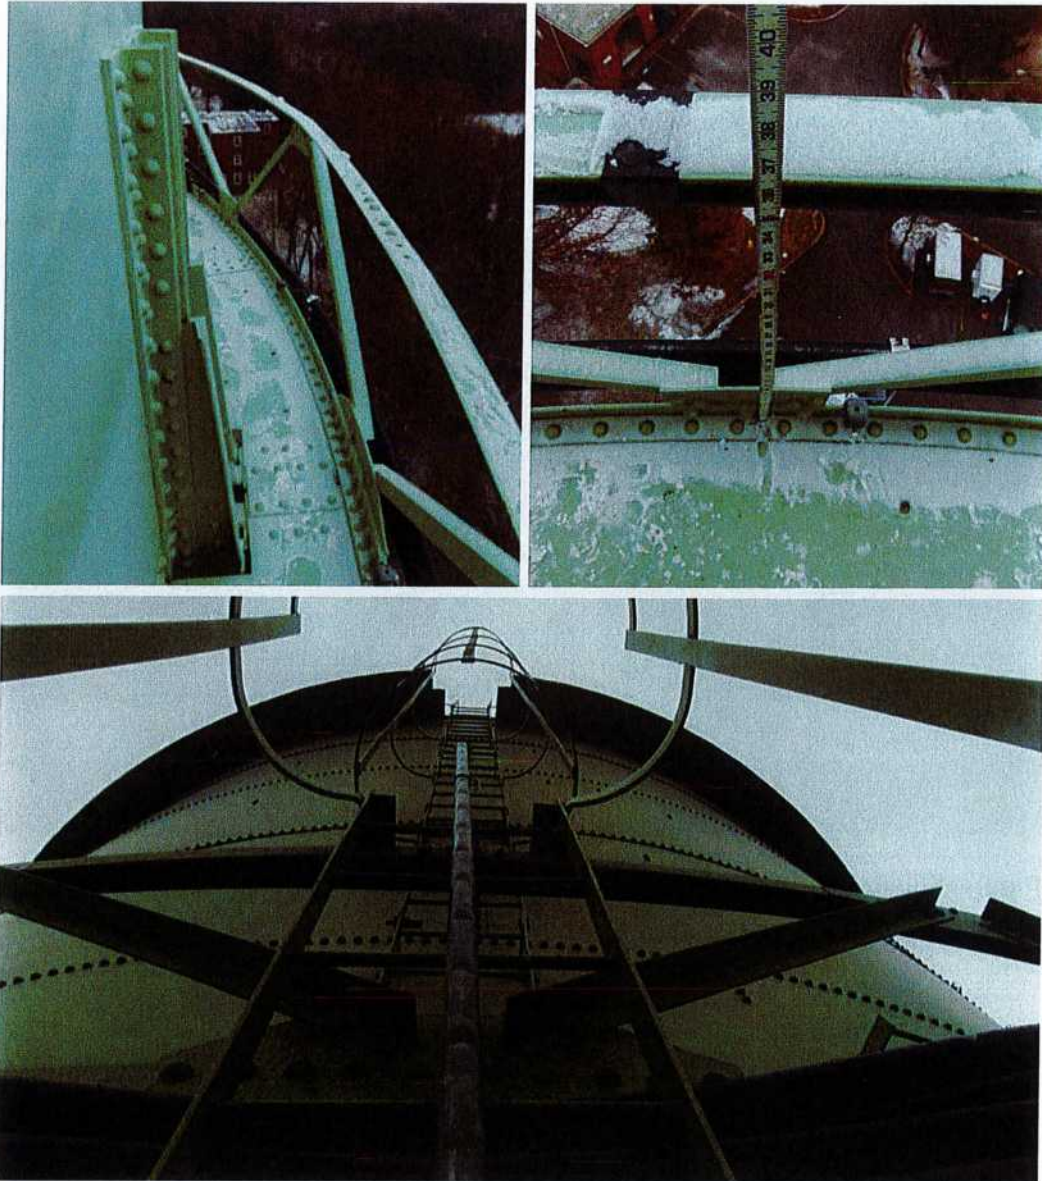
Photos show the condition of the existing handrail system. The handrail is only 36" high and is not equipped with an intermediate rail and is not in compliance with **OSHA 29 CFR 1910.23(e)(1)**. We recommend raising the existing handrail system to the required 42", installing an intermediate rail, cutting out a section of the handrail at the junction of the tower access ladder and structural girder, the width of the tower access ladder and installing the necessary bracing to keep railing at design strength, and installing a swing gate at the opening in the handrail at the junction of the tower access ladder and structural girder.

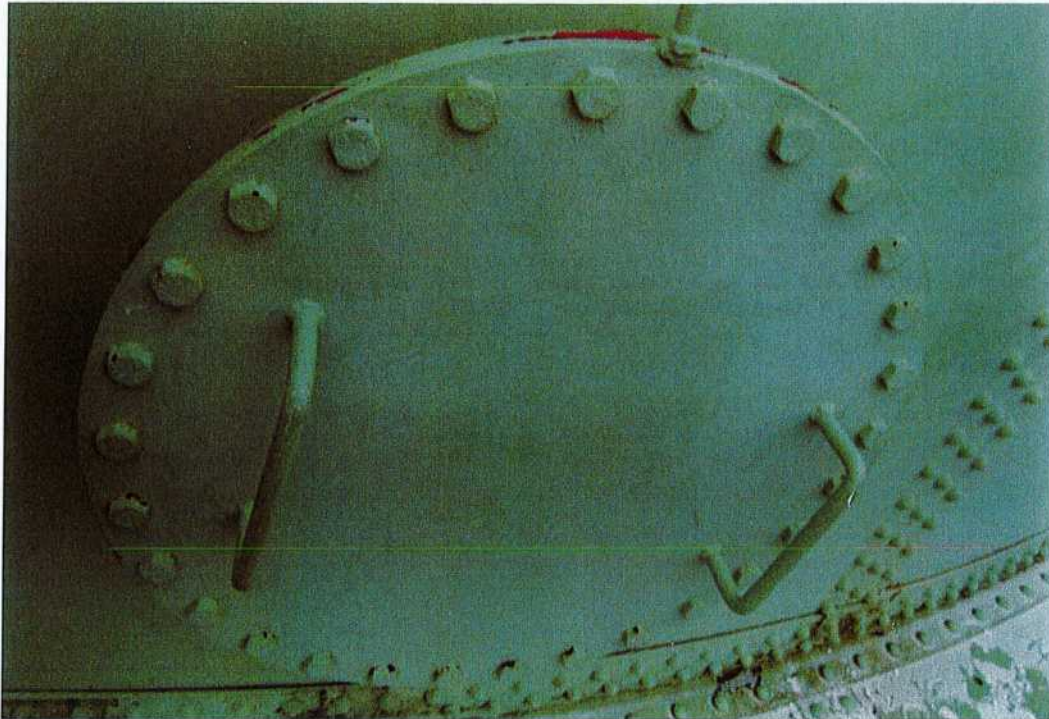
Photo shows the condition of the existing 24" shell manway. **AWWA D100-11;7.4.4** states, "Two shell manholes shall be provided in the first ring of the shell." The following items are required to bring the tank into compliance with **AWWA D100-11, 7.4.4** and **OSHA 1910.146 (h)(5)(ii): Confined Spaces**.

We recommend :

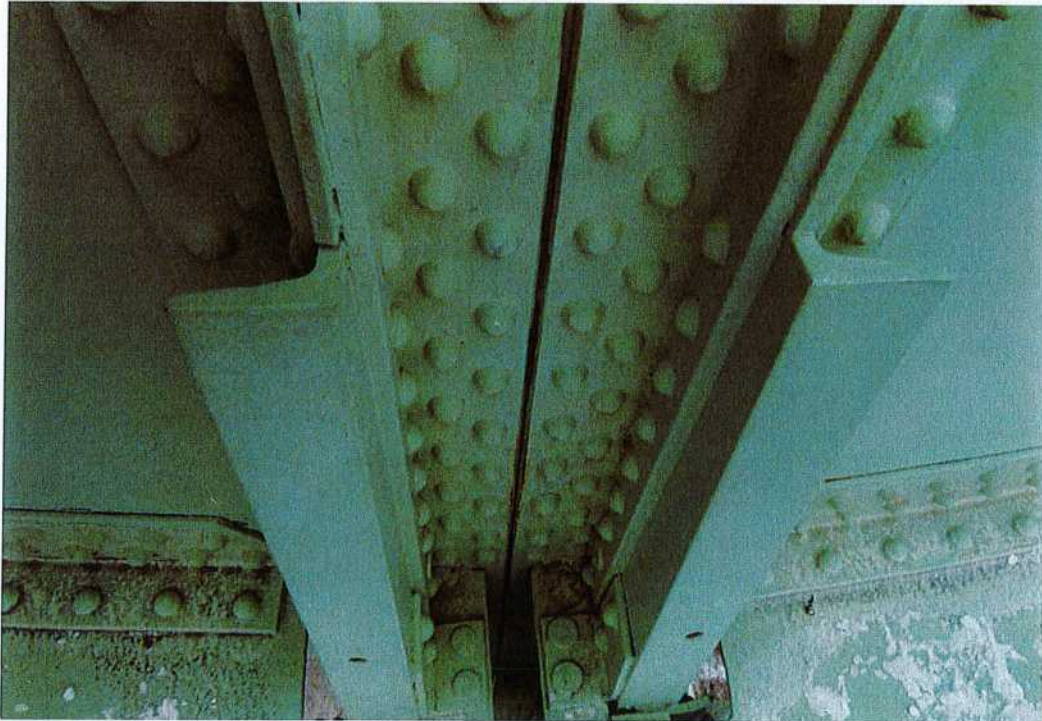
Photo shows the condition of the posthead connections. The postheads secure the column legs to the tank shell and support the tank's live and dead load. The postheads appear to be in good condition.

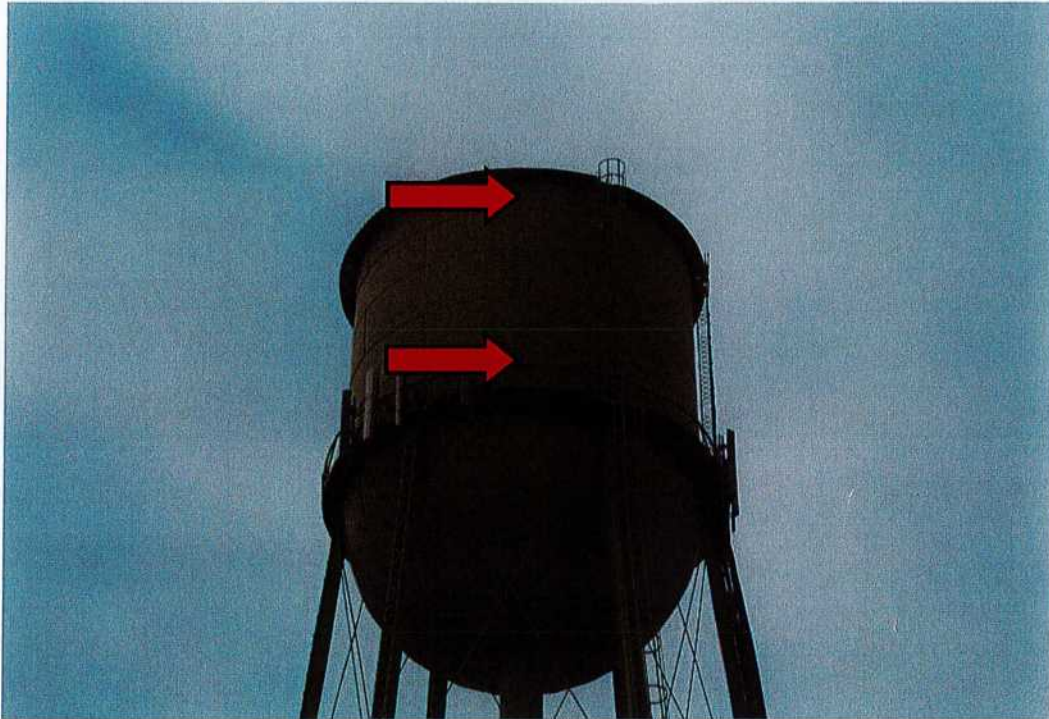
Photo shows the tank is not equipped with a liquid level indicator. We recommend installing a liquid level indicator, complete with target board and float.

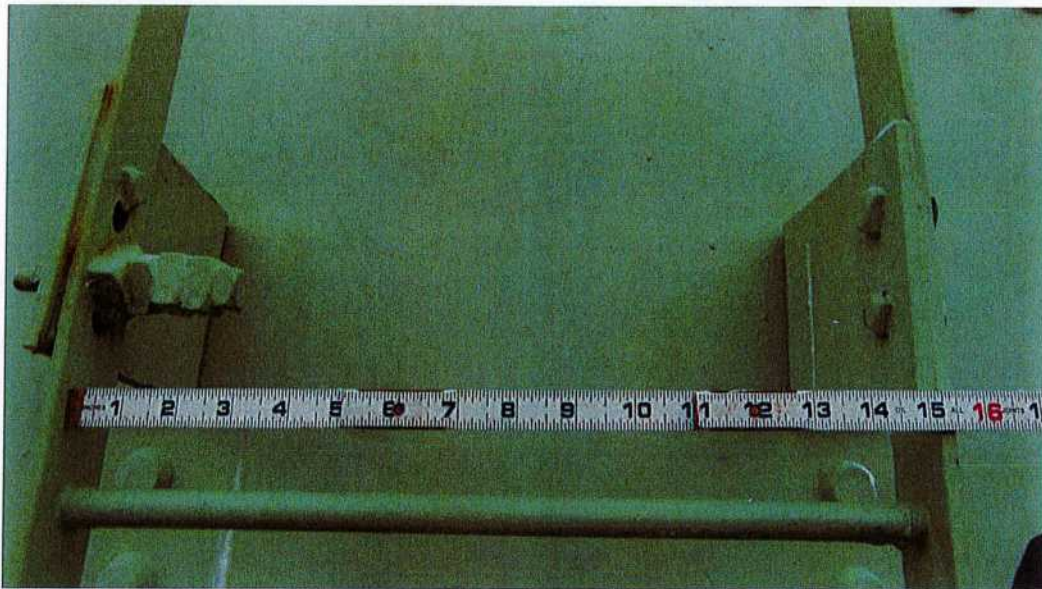
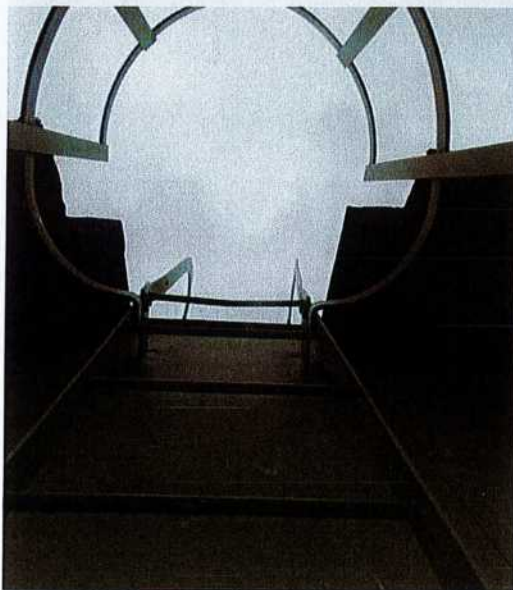
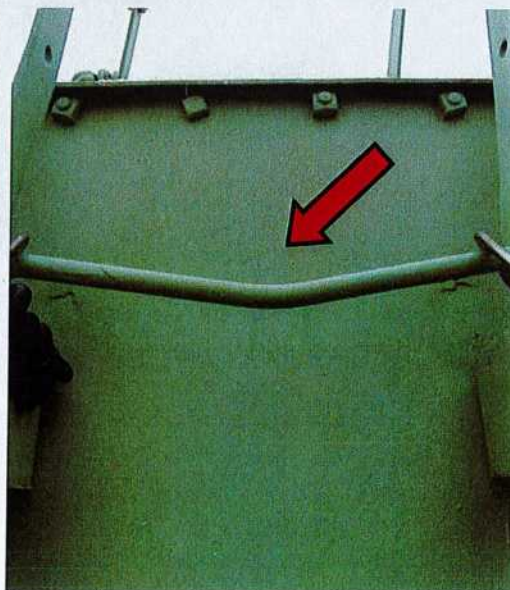
Shell/roof access ladder in above photos is not equipped with anti-skid rungs and is 15" wide. **Notice the rung is bent.** OSHA 1910.27 Ladders states, "Minimum clear distance between the sides of individual rung/step ladders and between the side rails of other fixed ladders must be 16" (41 cm)." OSHA 1910.27 states: "Rungs... must be corrugated, knurled, dimpled, coated with skid-resistant material or treated to minimize slipping." We recommend installing a anti-skid rung equipped, shell/roof access ladder complete with stand-offs every 10' on center and a cable type ladder safety device.

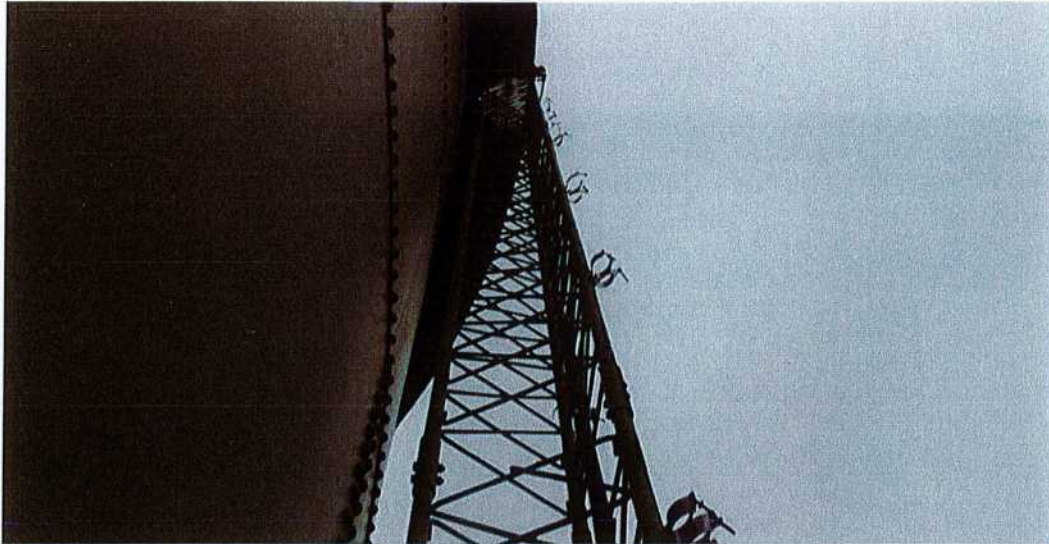
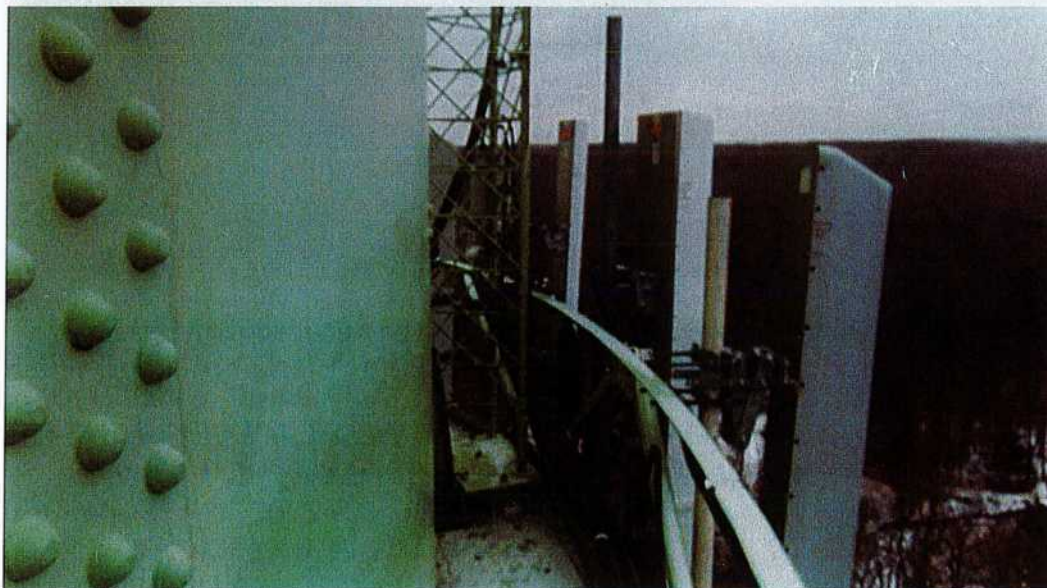
Photos show the antenna system located on the tank. **Notice the walkway is obstructed with an antenna.** AWWA D100-11; Section A.5.6.2 Health and Safety states, "Antennas and related equipment should not interfere with OSHA defined access. OSHA 29 CFR 1910.22 states, (a) "Surface conditions and clearances, (1) Surfaces shall be designed, constructed and maintained free of recognized hazards that can result in death or serious injury to employees. (3) **A minimum free clearance of 18 inches** shall be provided for employee passage around or between obstructions." We recommend relocating the antenna system.

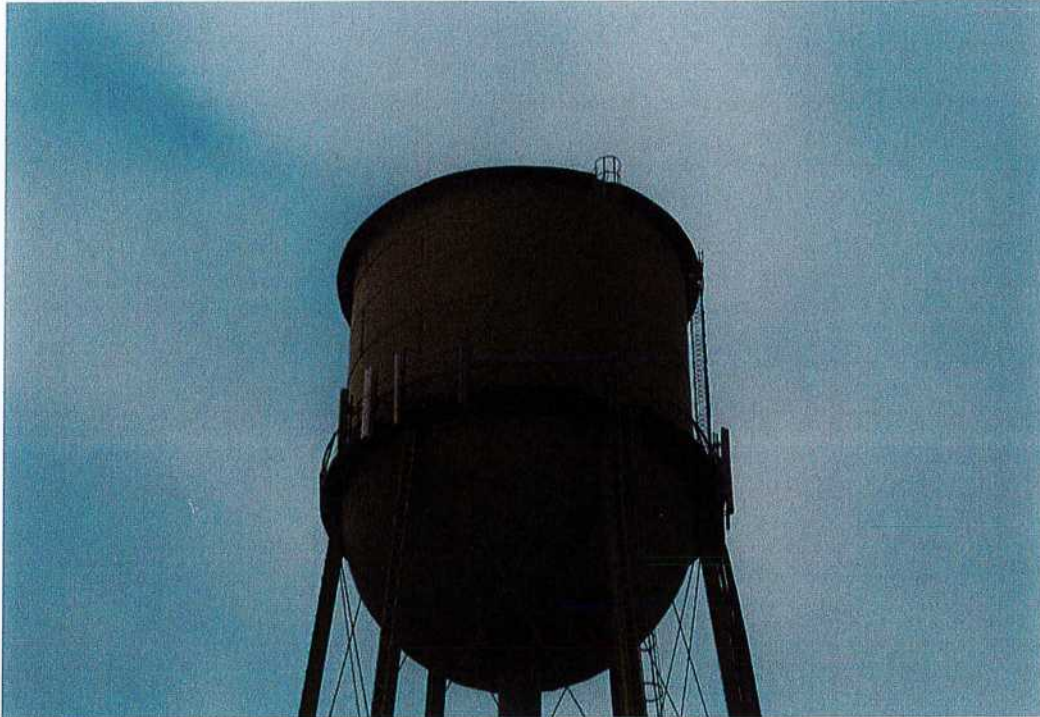
Photo shows that the tank roof is not equipped with a required fall protection system. **OSHA 1910.23 (c)** requires fall protection on the edges of all walking working surfaces. We recommend installing a 42" high handrail system around the circumference of the tank roof, complete with toeboard, intermediate rail and a swing gate at the junction of the shell-to-roof access ladder and tank roof.

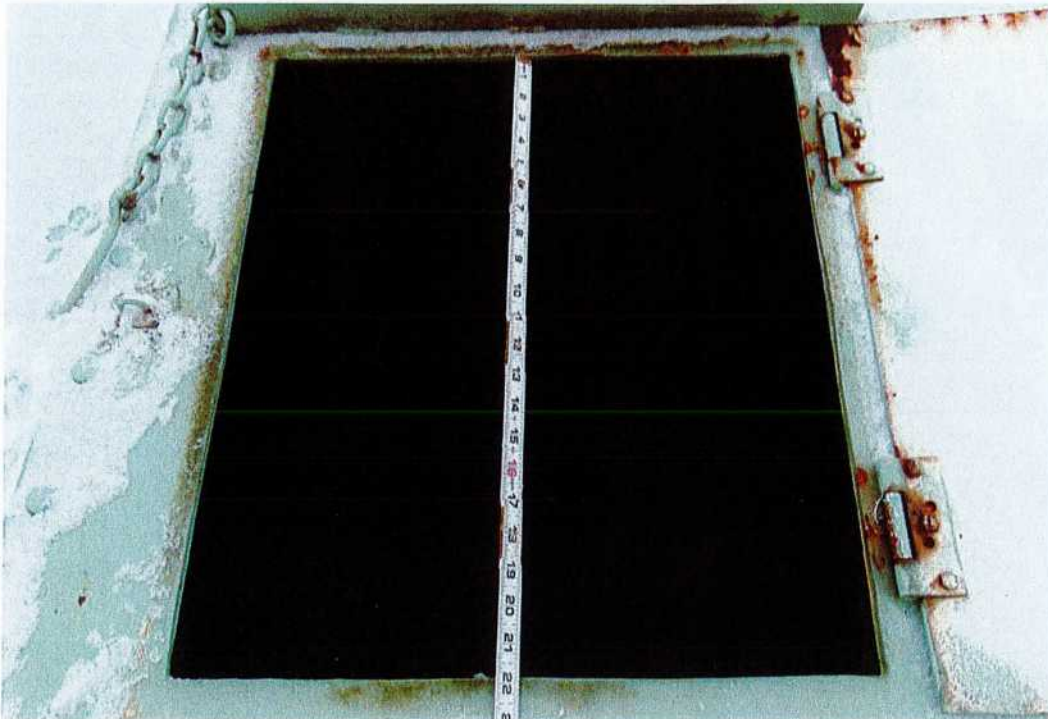
Photo shows the condition of the 20" x 22" existing roof manway. **Notice the manway does not have a 4" curb as required by AWWA D100-11; 5.4.3.1** "A roof opening with hinged cover and hasp for locking shall be provided near the outside tank ladder, or roof ladder if provided. The opening shall have a minimum dimension of 24 in. (610 mm), or as required by OSHA, if used to access an inside tank ladder. The opening shall have a curb at least 4 in. (102 mm) high, and the cover shall have a downward overlap of at least 2 in. (51 mm). Roof openings on this tank require the following to be in compliance with OSHA 1910.146(h)(5)(ii): **Confined Spaces** and AWWA D100-11 5.4.3.1: **roof openings**.

We recommend:

Replace existing roof manway with 30" manway

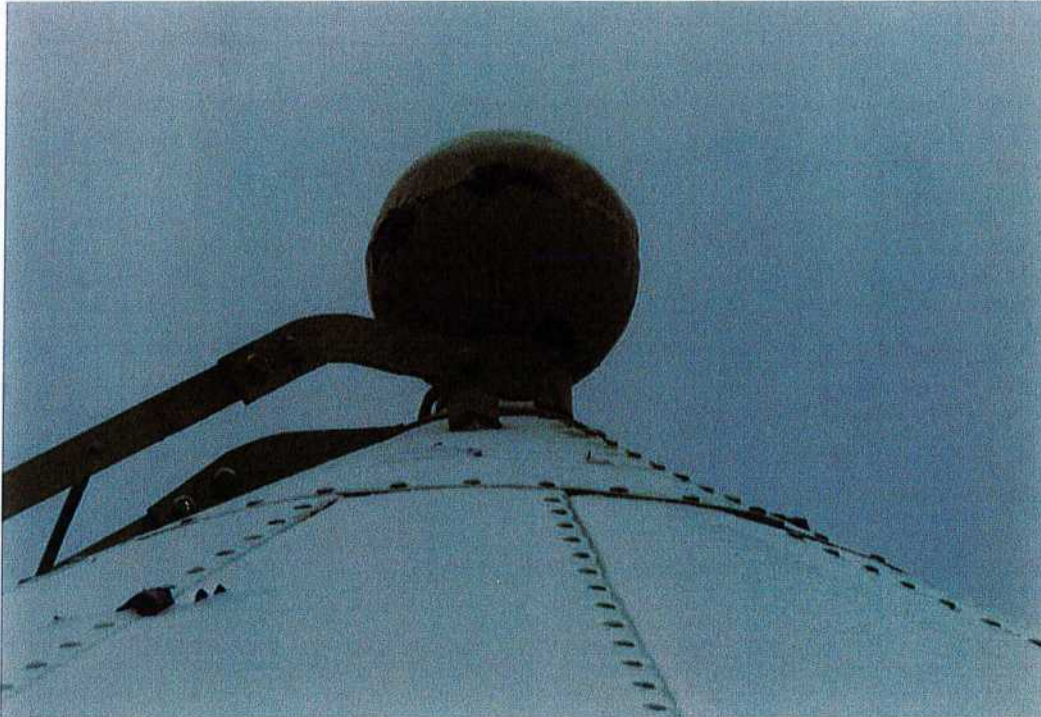
Photo shows the condition of the finial ball. A finial ball does not provide adequate ventilation. The venting area is of an inadequate size and is not compliant with **AWWA D100-11; 5.5: Vent**. **An improperly vented tank may cause external pressure to act on the tank which can cause buckling even at low pressure differential.** We recommend replacing the finial ball with a vacuum-pressure, frost proof vent and screen.

This work should be performed on an emergency basis.

\$7,400	Replace the finial ball with a vacuum-pressure, frost proof vent and screen on an EMERGENCY basis.	X			X

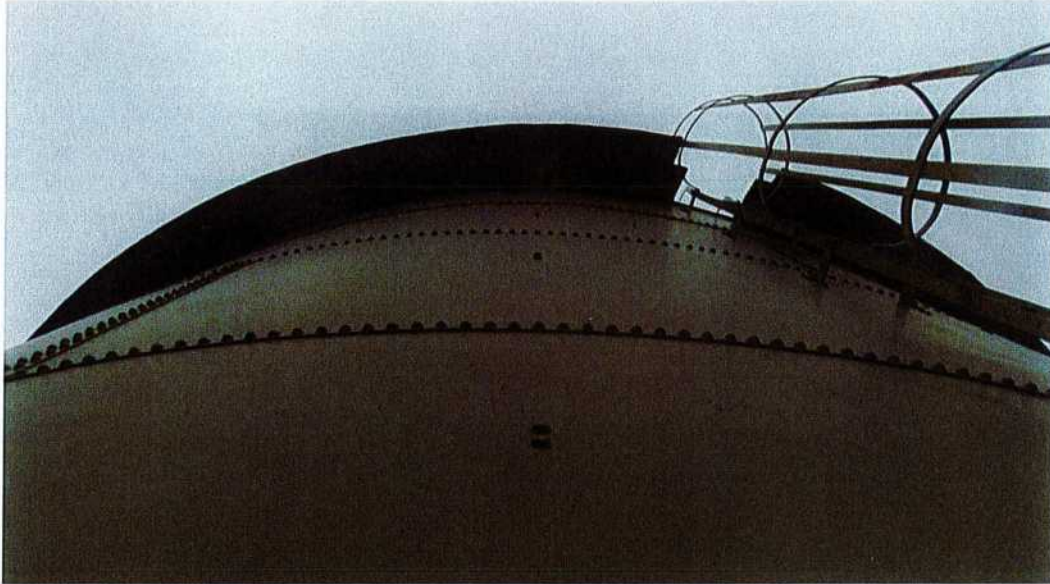
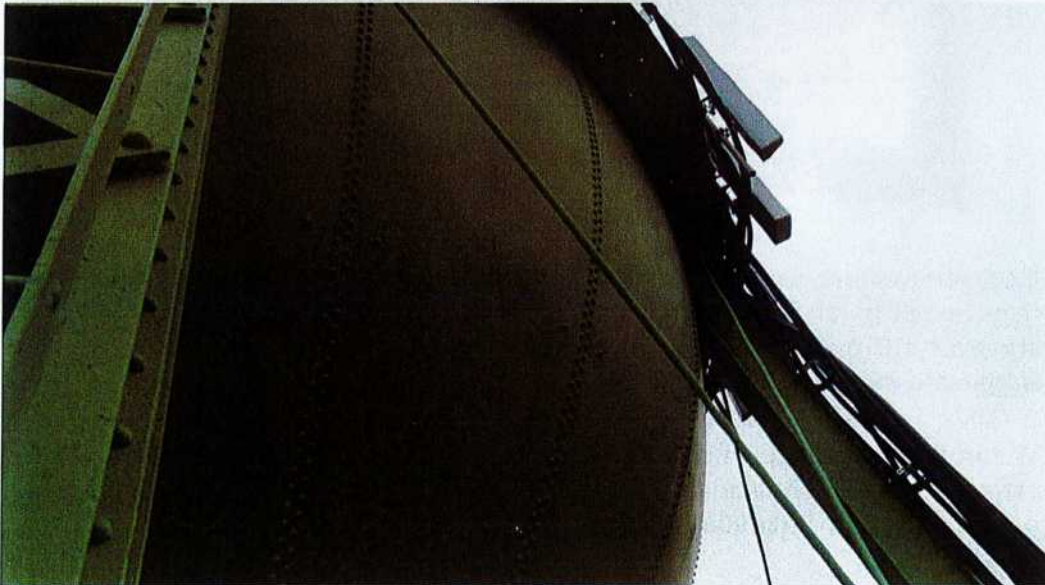
Photos show the tank exterior coating system. The overall exterior coating system appears to be in good condition. We recommend re-evaluating the tank exterior in 2 to 3 years.
