**Livingston County
Water and Sewer Authority**

**Leicester/York Regional Water Supply
Expansion
Engineering Report Amendment #1**

March 2024

County of Livingston
1 Court Street, Rm B02
Geneseo, NY 14454
RE: 6 Murray Drive
350,000 Gallon EWT
March 4, 2016 & April 12, 2016
Mr. John Driscoll
S.C.S.
(585) 243-7505
Job No. 316029

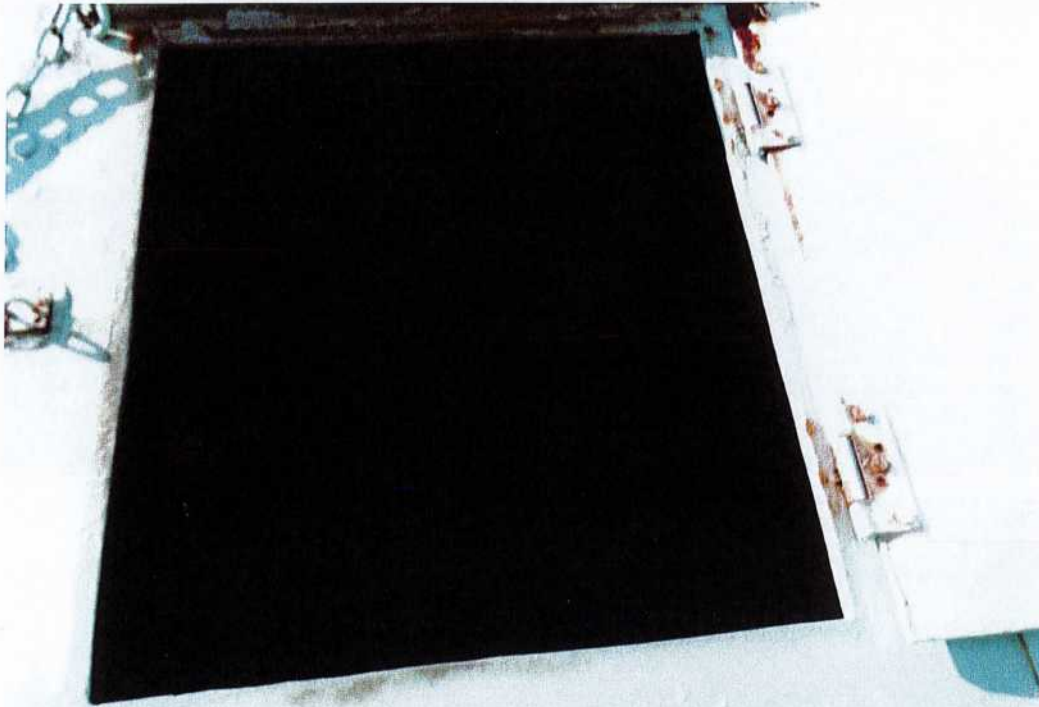
Photo shows tank is not equipped with an interior access ladder. We recommend installing an **OSHA** compliant interior access ladder complete with standoffs every 10' on center and a cable type ladder safety device at the primary and suggested secondary roof manway.

We further recommend installing compliant interior bowl ladders complete with standoffs every 10' on center and cable type ladder safety devices at the primary and suggested secondary shell manways.

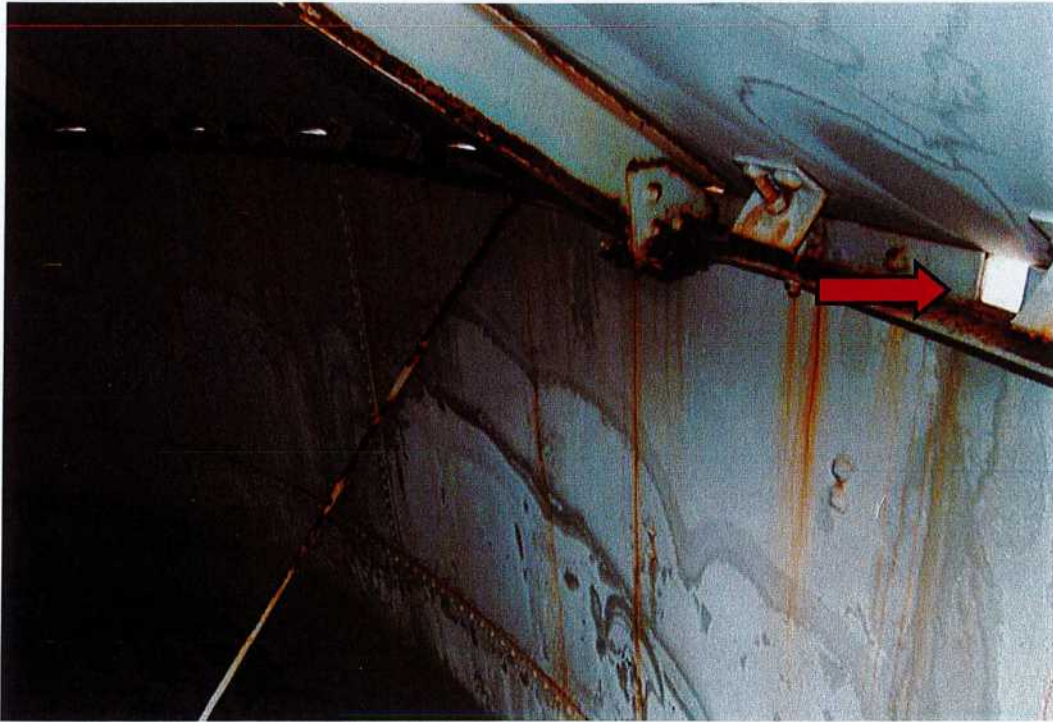
Photo shows the condition of the interior roof-to-rim angle connection. We recommend remounting the roof using gusset plates approximately every 3' on center, then seam sealing using Sikaflex® 1a around the circumference of the roof-to-shell connection to prevent the ingress of contaminants into the tank.

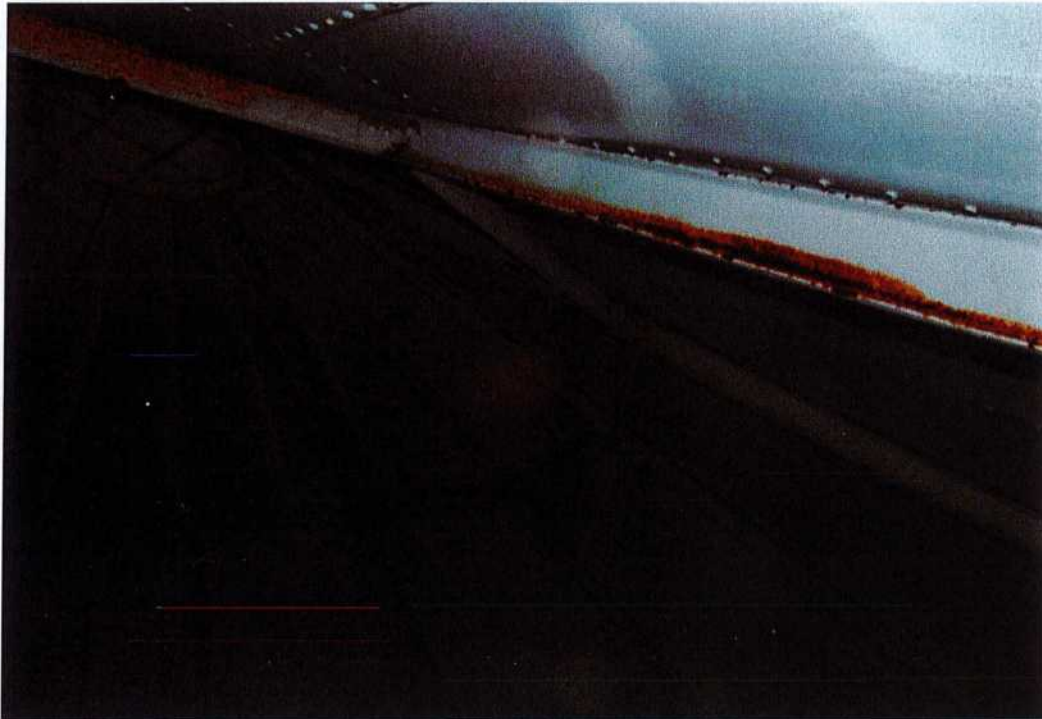
Photo shows the condition of the interior roof. It appears to be in good condition.

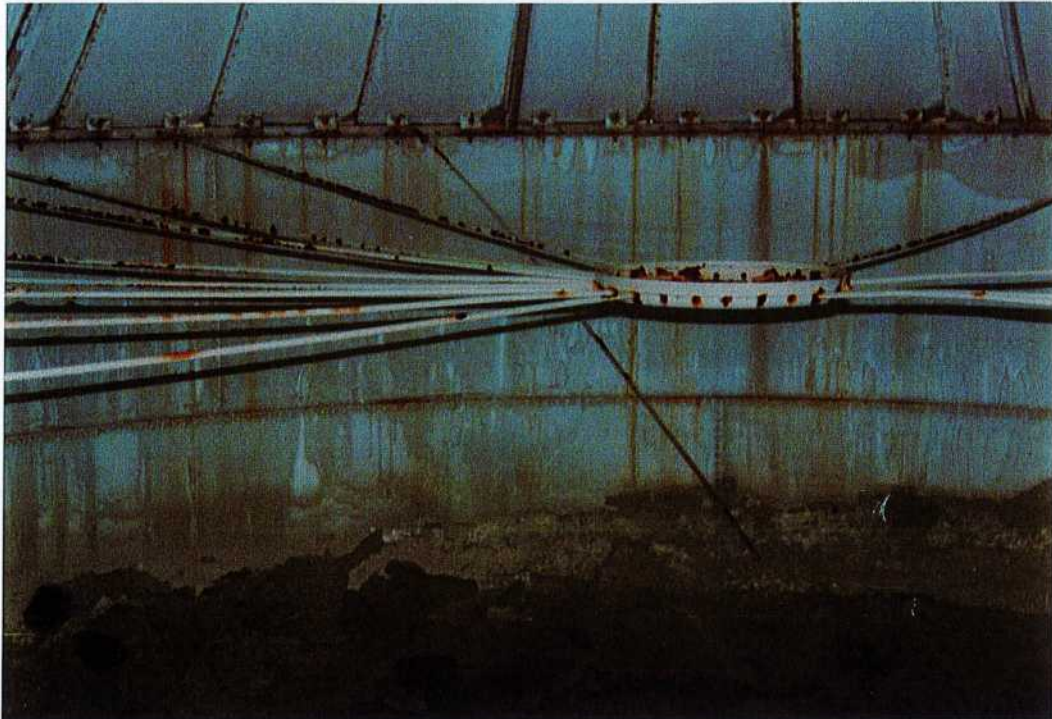
Photo shows the condition of spider rods and hub assembly. The assembly no longer affects the structural integrity of the tank, it is for erection purposes only. We recommend removing the spider rod assembly from the tank.

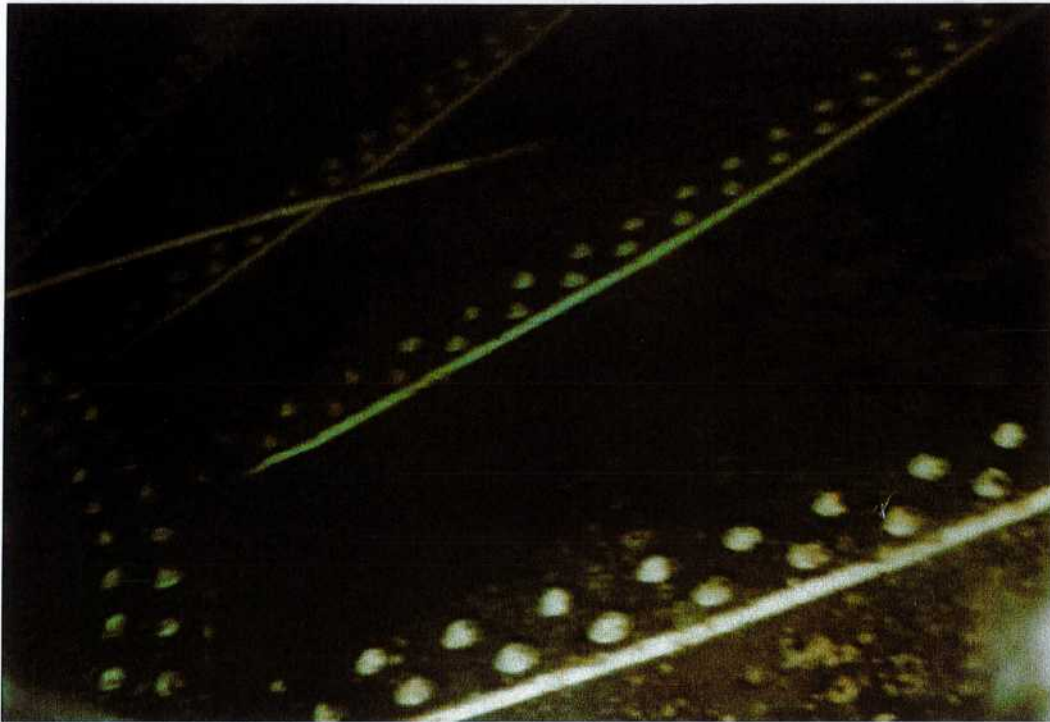
Photo shows sediment and debris in the tank. We recommend that cleaning be performed in order to prevent contamination issues associated with excessive sedimentation buildup.

This work should be performed on an emergency basis.

We further recommend installing a passive cathodic protection system.

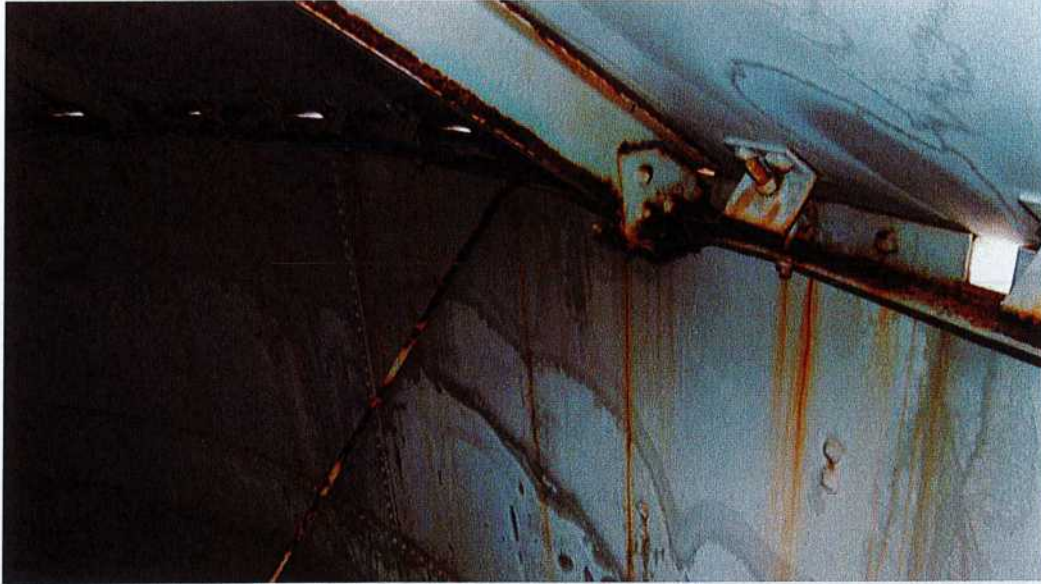
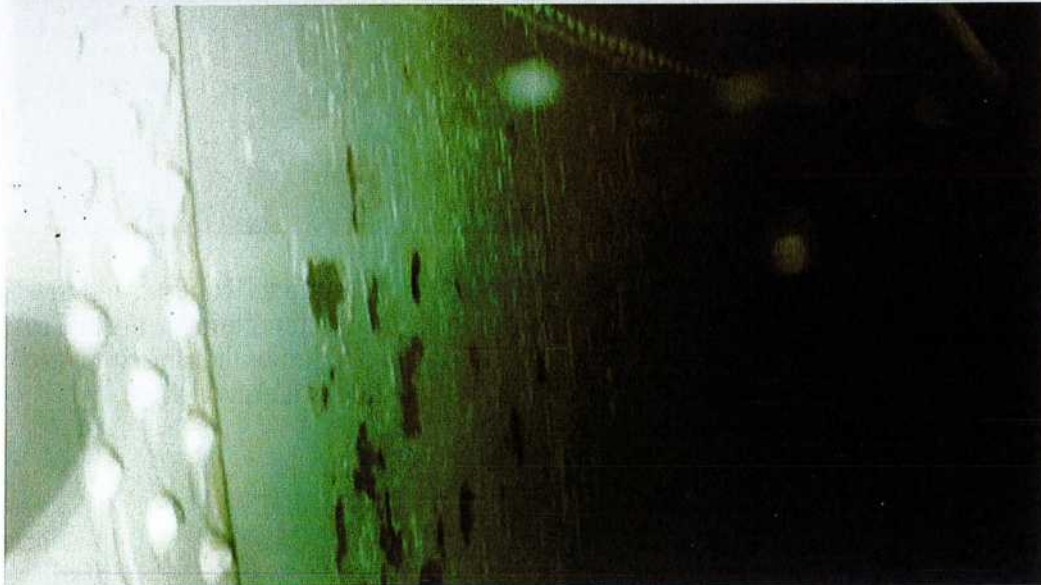
Photos show the tank interior coating system. We recommend to sandblast, SSPC-SP10 (near white), all rusted and abraded interior areas and brush blast, SSPC-SP7, all remaining interior areas. All areas sandblasted to a #10 as well as all weld seams will receive one (1) spot coat of epoxy primer and one full coat epoxy will then be applied to the entire tank to achieve 8 to 10 mils of total dry film thickness. Total milage includes a combination of the existing and new coating.

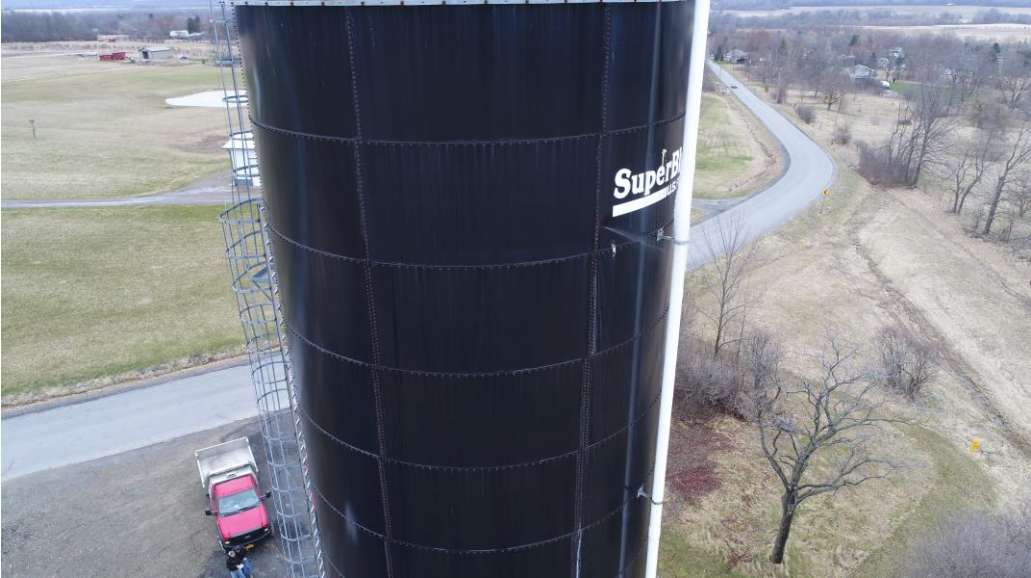
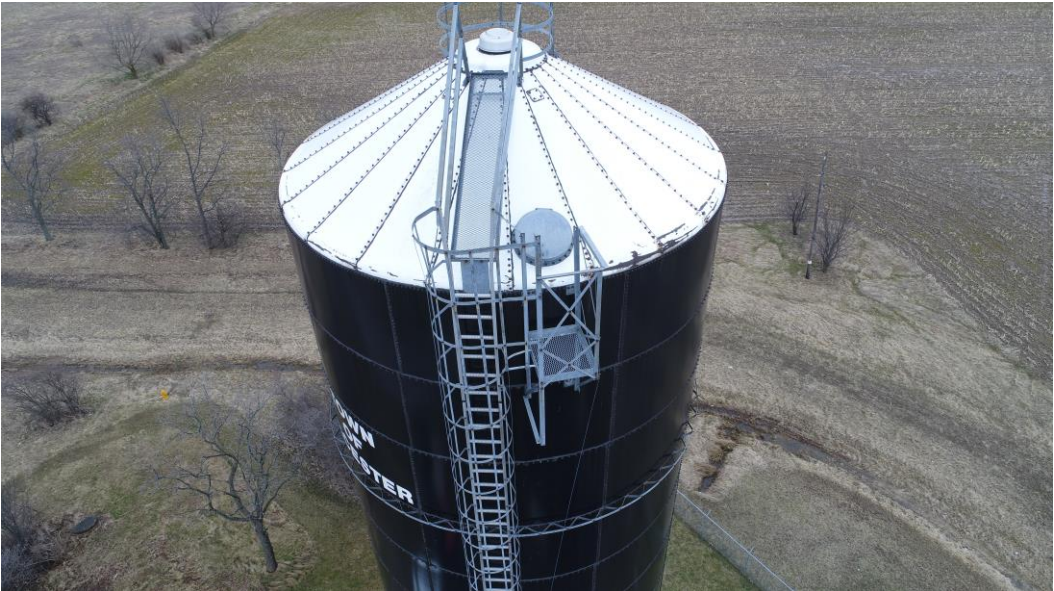
Leak in the tank

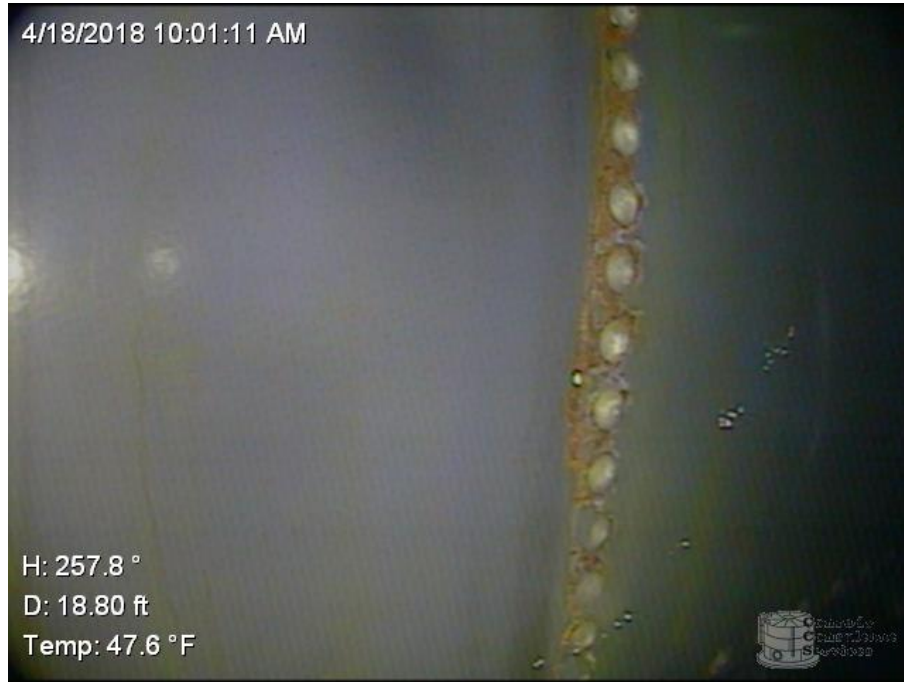
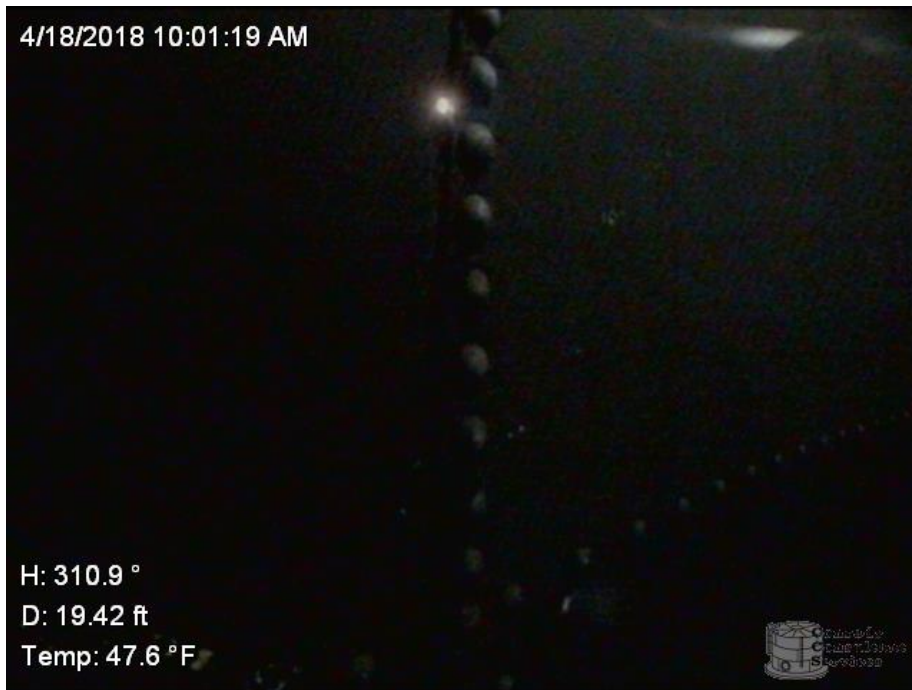
LEAK ON PLATE JOINT
