Livingston County Water and Sewer Authority

LCWSA Regional Water Supply Project Engineering Report Amendment #2

September 2025

DWSRF Project No. 19225

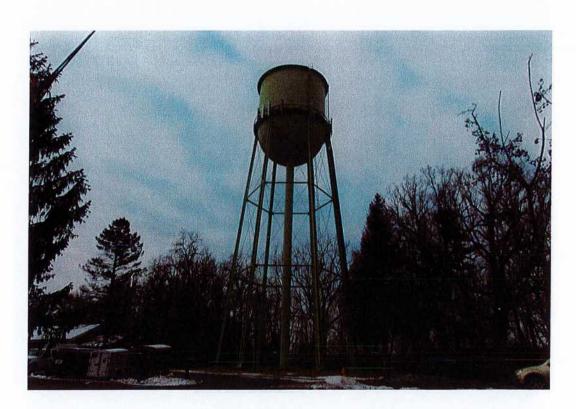
Photo shows the tank is not secured with fencing. We recommend fencing the area around the tank. We further recommend posting a **No Trespassing** sign and a **Warning, Tampering With This Facility is a Federal Offense** (US code title 42, section 300i-1) sign. Fence installation to be done by others.

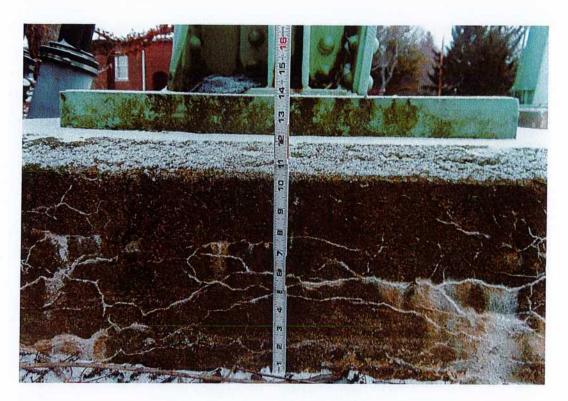
Photo shows the condition of the foundations, which meet the height requirements of AWWA D100-11; 12.7.1: Foundations.

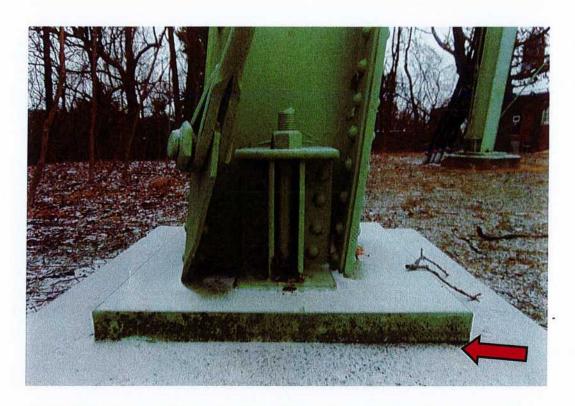
Photo shows the condition of the foundations. We recommend caulking around the base of the tank foundation connections to prevent water from entering.

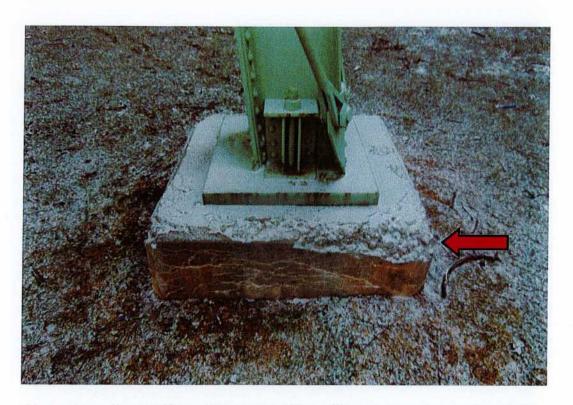
Photo shows the condition of the foundations. We recommend removing all dirt, debris and loose gravel from the foundations, repairing any cracks and spalling in the concrete with a commercial non-shrinking grout and sealing the foundations with a sealant.

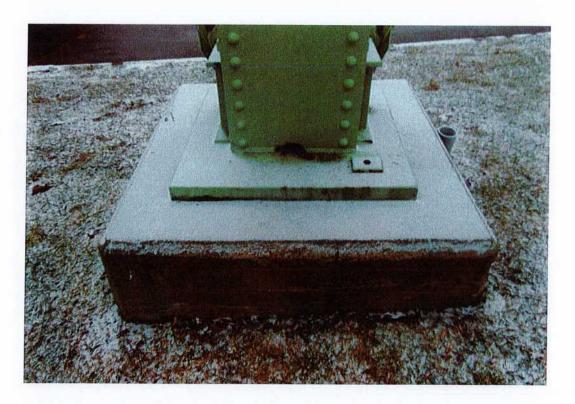
Photo shows more of the tank foundation. We recommend electrically grounding the tank for lightning protection as required by OSHA Act 29 CFR 1926 (K).

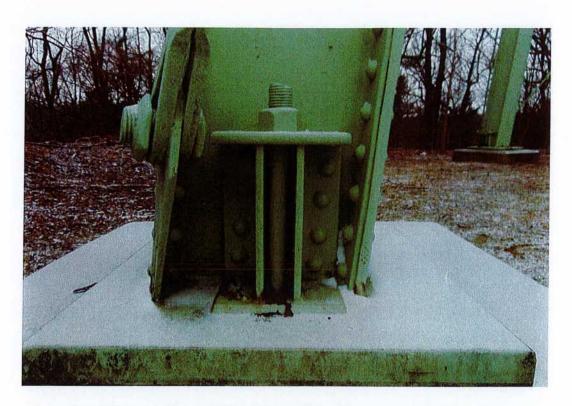
Photo shows the condition of the anchor bolts. The structural integrity of the anchor bolts should be maintained to withstand 100 mph winds blowing from any direction as required by AWWA D100-11; 3.8: Anchorage. We recommend cleaning the area around the anchor bolts, tightening the anchor bolt nuts to specifications and welding around the circumference of the bolt-to-nut and nut-to-base plate connections to reinforce.

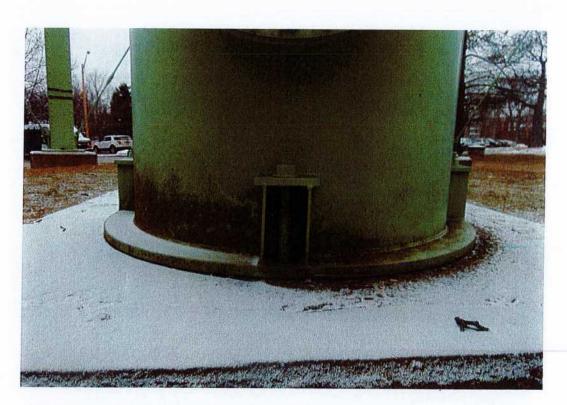
Photo shows the base of the riser pipe. Currently there is no riser drain valve. A drain valve performs two functions; it allows the tank to be drained and it is used as a blowout to remove silt and scale from the lower portion of the tank. We recommend installing a frost proof drain valve, complete with locking device to prevent unauthorized draining of the tank and a splash pad to direct water away from the foundation.

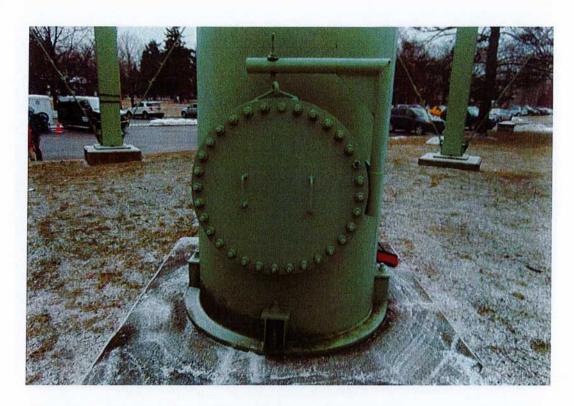
Photo shows the condition of the 24" riser manway. This manway meets the size requirements for AWWA D100-11: 5.4.4. We recommend posting a Confined Space Entry sign and installing maintenance free galvanized steel bolts.

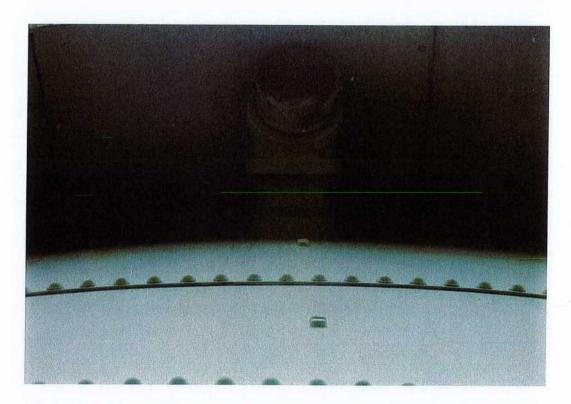
Photo shows the condition of the stub overflow pipe. The overflow pipe is not equipped with a flapper valve. We recommend extending the overflow down the exterior to grade with the same sized pipe, complete with standoffs every 10' on center, an elbow at the base fitted with a flapper valve and screen to prevent the ingress of contaminants into the water supply and a splash pad to direct water away from the foundation.

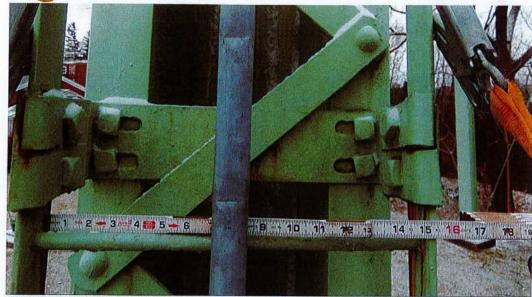
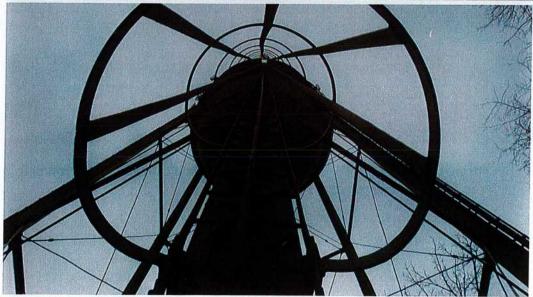
Tower access ladder in above photos is not equipped with anti-skid rungs and is 15" wide. Notice the notched rail safety slide. OSHA 1910.27 Ladders states, "Minimum clear distance between the sides of individual rung/step ladders and between the side rails of other fixed ladders must be 16" (41 cm)." OSHA 1910.27 states, "Rungs-must be corrugated, knurled, dimpled, coated with skid-resistant material or treated to minimize slipping." We recommend installing a compliant tower access ladder complete with standoffs every 10' on center, a cable type ladder safety device, a lockable ladder guard to prevent unauthorized access and posting a Fall Protection Required sign.

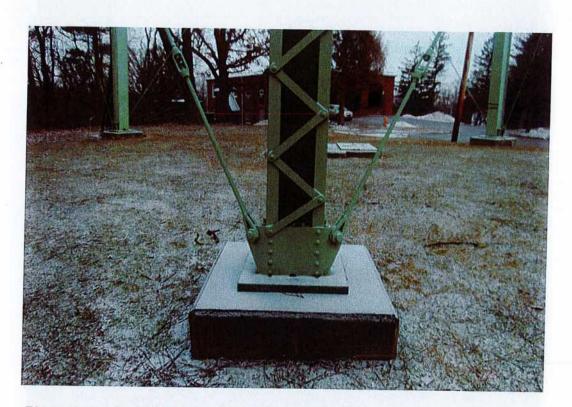
Photo shows the lattice legs. We recommend installing climbing guards on all legs to prevent unauthorized access.

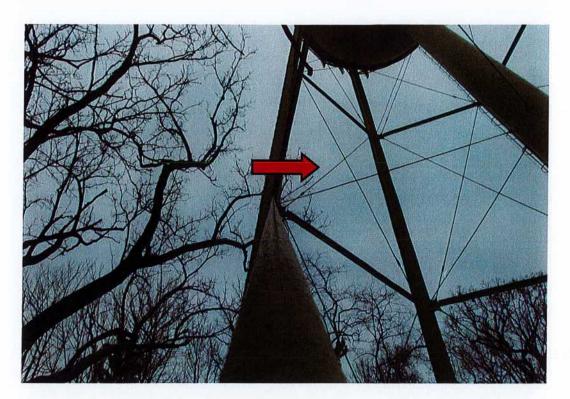
Photo shows the condition of the windage rods. The windage rods are designed to resist and stabilize the tower structure against wind and seismic loads combined with dead and live loads. The rods should withstand 100 mph winds blowing from any direction. If the bracing remains loose, a sudden collapse could occur. We recommend adjusting the windage rods as needed, to withstand 100 mph winds blowing from any direction, as required by AWWA D100-11; 3.1.4.

This work should be performed on an emergency basis.

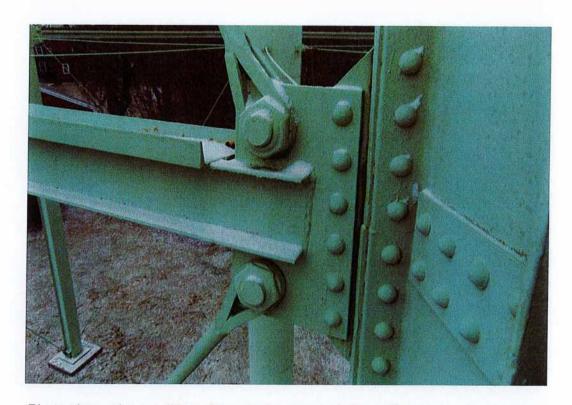
Photo shows the condition of the strut end connections. The strut ends appear to be in good condition.

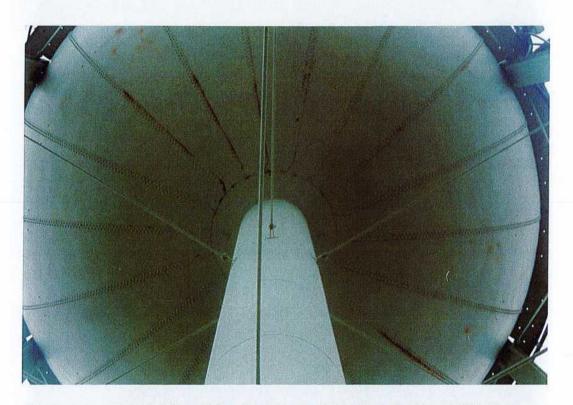
Photo shows the condition of the riser pipe and bowl connection, which appears to be in good condition.

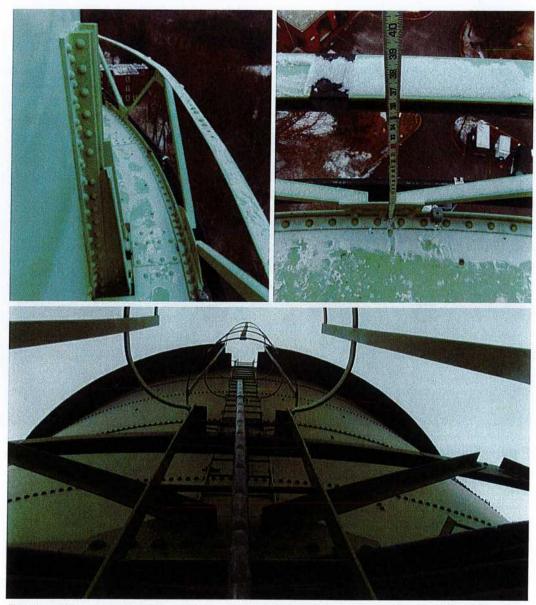
Photos show the condition of the existing handrail system. The handrail is only 36" high and is not equipped with an intermediate rail and is not in compliance with OSHA 29 CFR 1910.23(e)(1). We recommend raising the existing handrail system to the required 42", installing an intermediate rail, cutting out a section of the handrail at the junction of the tower access ladder and structural girder, the width of the tower access ladder and installing the necessary bracing to keep railing at design strength, and installing a swing gate at the opening in the handrail at the junction of the tower access ladder and structural girder.

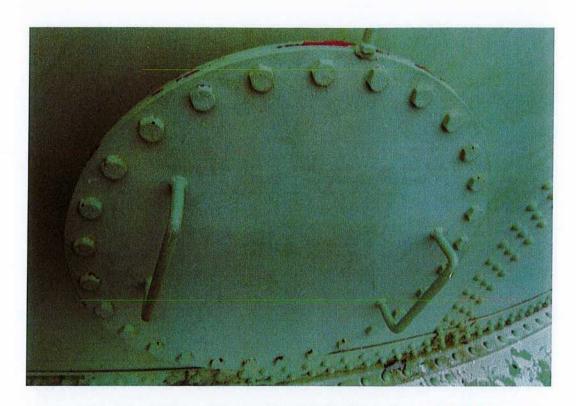
Photo shows the condition of the existing 24" shell manway. AWWA D100-11;7.4.4 states, "Two shell manholes shall be provided in the first ring of the shell." The following items are required to bring the tank into compliance with AWWA D100-11, 7.4.4 and OSHA 1910.146 (h)(5)(ii): Confined Spaces.

Install 30" secondary shell manway 180° from primary manway Install davit slide on suggested secondary shell manway Post **Confined Space Entry** signs

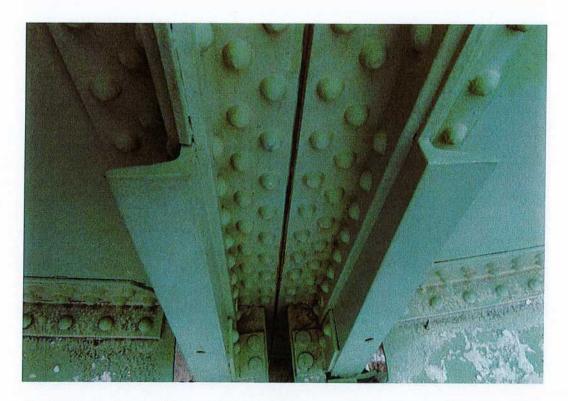
Photo shows the condition of the posthead connections. The postheads secure the column legs to the tank shell and support the tank's live and dead load. The postheads appear to be in good condition.

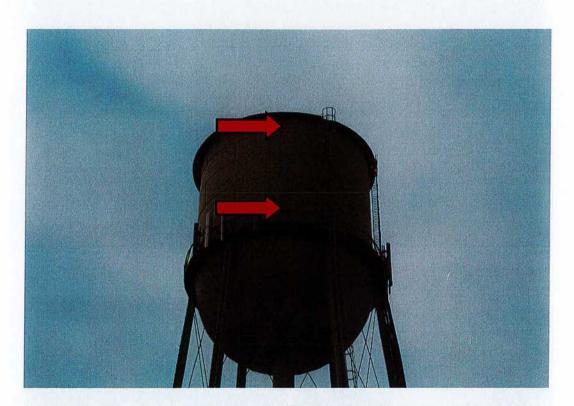
Photo shows the tank is not equipped with a liquid level indicator. We recommend installing a liquid level indicator, complete with target board and float.

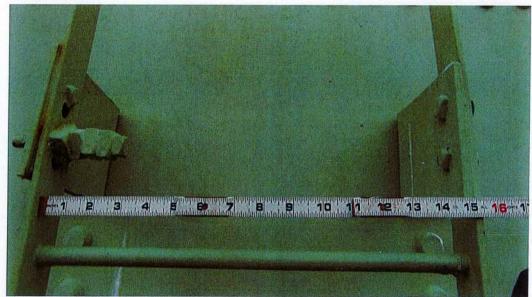
Shell/roof access ladder in above photos is not equipped with anti-skid rungs and is 15" wide. **Notice the rung is bent.** OSHA 1910.27 Ladders states, "Minimum clear distance between the sides of individual rung/step ladders and between the side rails of other fixed ladders must be 16" (41 cm)." OSHA 1910.27 states: "Rungs... must be corrugated, knurled, dimpled, coated with skid-resistant material or treated to minimize slipping." We recommend installing a anti-skid rung equipped, shell/roof access ladder complete with stand-offs every 10' on center and a cable type ladder safety device.

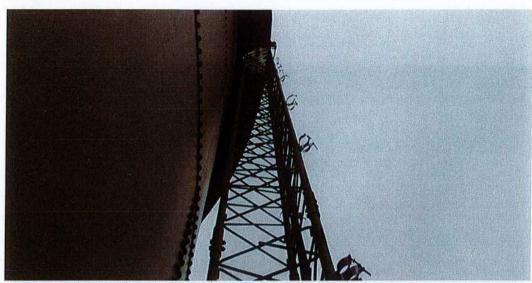
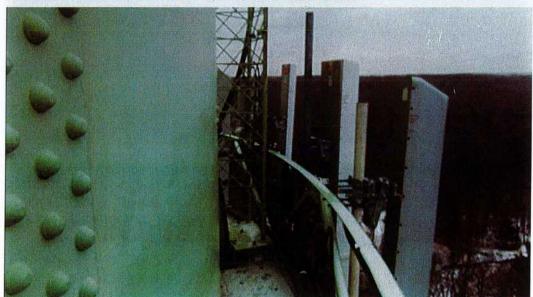
Photos show the antenna system located on the tank. **Notice the walkway is obstructed with an antenna**. AWWA D100-11; Section A.5.6.2 Health and Safety states, "Antennas and related equipment should not interfere with OSHA defined access. OSHA 29 CFR 1910.22 states, (a) "Surface conditions and clearances, (1) Surfaces shall be designed, constructed and maintained free of recognized hazards that can result in death or serious injury to employees. (3) A minimum free clearance of 18 inches shall be provided for employee passage around or between obstructions." We recommend relocating the antenna system.

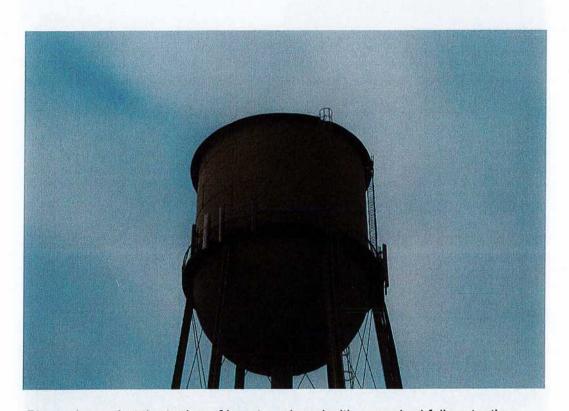
Photo shows that the tank roof is not equipped with a required fall protection system. OSHA 1910.23 (c) requires fall protection on the edges of all walking working surfaces. We recommend installing a 42" high handrail system around the circumference of the tank roof, complete with toeboard, intermediate rail and a swing gate at the junction of the shell-to-roof access ladder and tank roof.

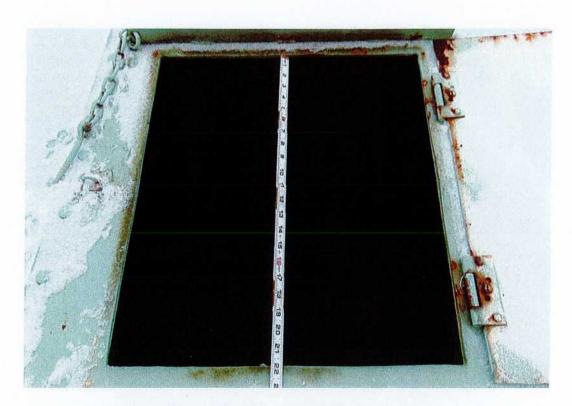
Photo shows the condition of the 20" x 22" existing roof manway. **Notice the manway does not have a 4" curb as required by AWWA D100-11**; 5.4.3.1 "A roof opening with hinged cover and hasp for locking shall be provided near the outside tank ladder, or roof ladder if provided. The opening shall have a minimum dimension of 24 in. (610 mm), or as required by OSHA, if used to access an inside tank ladder. The opening shall have a curb at least 4 in. (102 mm) high, and the cover shall have a downward overlap of at least 2 in. (51 mm). Roof openings on this tank require the following to be in compliance with OSHA 1910.146(h)(5)(ii): Confined Spaces and AWWA D100-11 5.4.3.1: roof openings.

Replace existing roof manway with 30" manway Install a 30" secondary roof manway 180° from primary roof manway Post **Confined Space Entry** signs

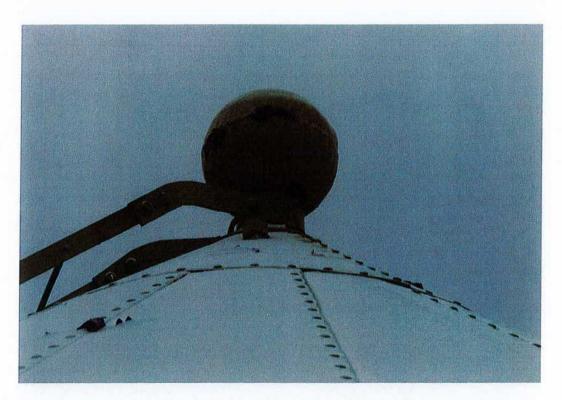
Photo shows the condition of the finial ball. A finial ball does not provide adequate ventilation. The venting area is of an inadequate size and is not compliant with AWWA D100-11; 5.5: Vent. An improperly vented tank may cause external pressure to act on the tank which can cause buckling even at low pressure differential. We recommend replacing the finial ball with a vacuum-pressure, frost proof vent and screen.

This work should be performed on an emergency basis.

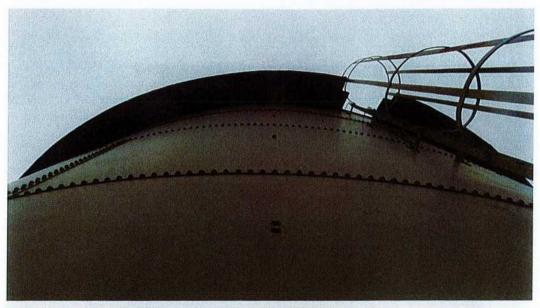
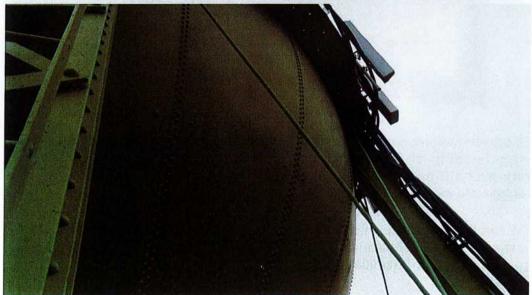
Photos show the tank exterior coating system. The overall exterior coating system appears to be in good condition. We recommend re-evaluating the tank exterior in 2 to 3 years.

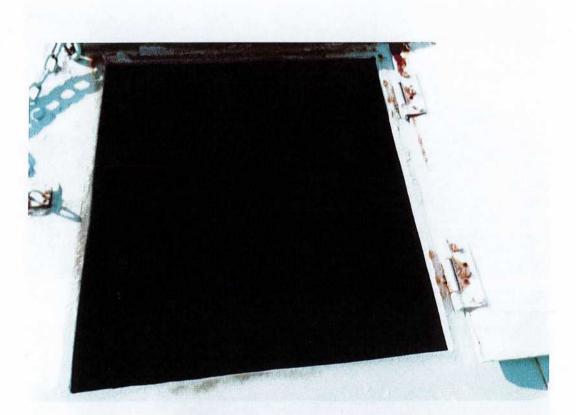
Photo shows tank is not equipped with an interior access ladder. We recommend installing an OSHA compliant interior access ladder complete with stand-offs every 10' on center and a cable type ladder safety device at the primary and suggested secondary roof manway.

We further recommend installing compliant interior bowl ladders complete with standoffs every 10' on center and cable type ladder safety devices at the primary and suggested secondary shell manways.

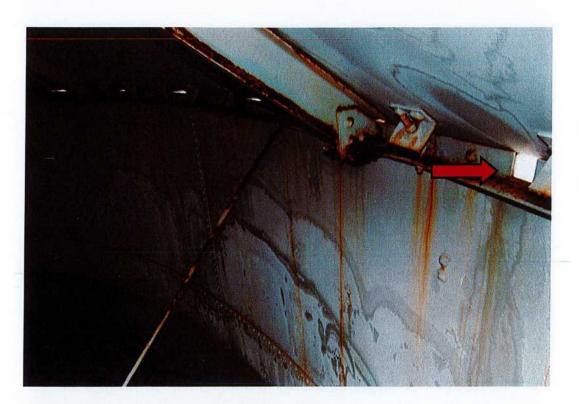
Photo shows the condition of the interior roof-to-rim angle connection. We recommend remounting the roof using gusset plates approximately every 3' on center, then seam sealing using Sikaflex® 1a around the circumference of the roof-to-shell connection to prevent the ingress of contaminants into the tank.

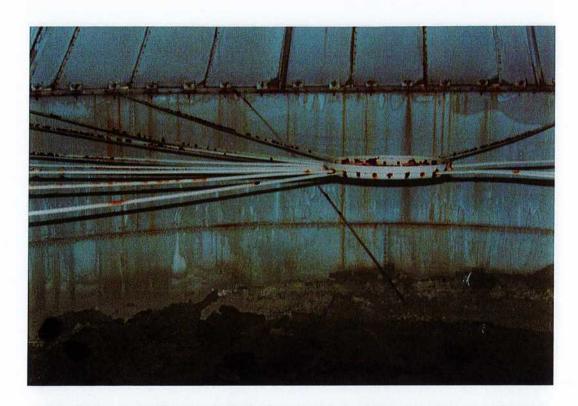
Photo shows the condition of spider rods and hub assembly. The assembly no longer affects the structural integrity of the tank, it is for erection purposes only. We recommend removing the spider rod assembly from the tank.

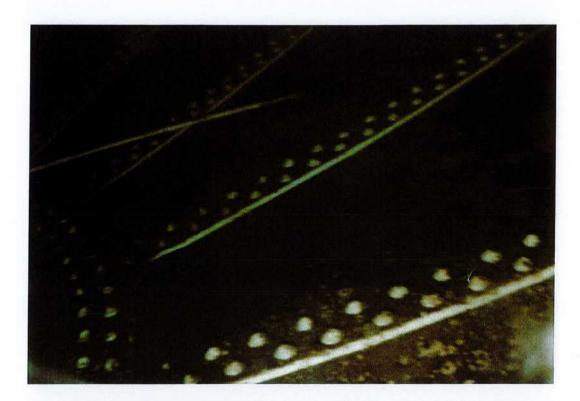
Photo shows sediment and debris in the tank. We recommend that cleaning be performed in order to prevent contamination issues associated with excessive sedimentation buildup.

This work should be performed on an emergency basis.

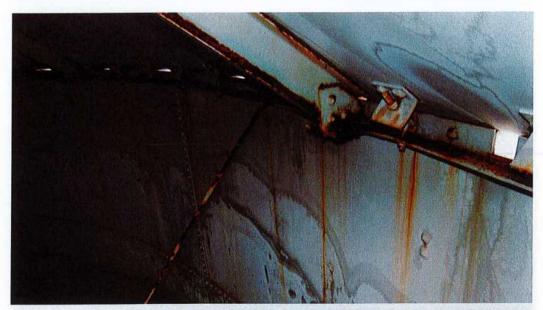
Photos show the tank interior coating system. We recommend to sandblast, SSPC-SP10 (near white), all rusted and abraded interior areas and brush blast, SSPC-SP7, all remaining interior areas. All areas sandblasted to a #10 as well as all weld seams will receive one (1) spot coat of epoxy primer and one full coat epoxy will then be applied to the entire tank to achieve 8 to 10 mils of total dry film thickness. Total milage includes a combination of the existing and new coating.

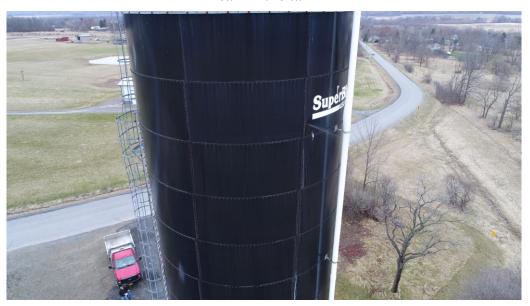
Town Tank Pictures 17

Leak in the tank

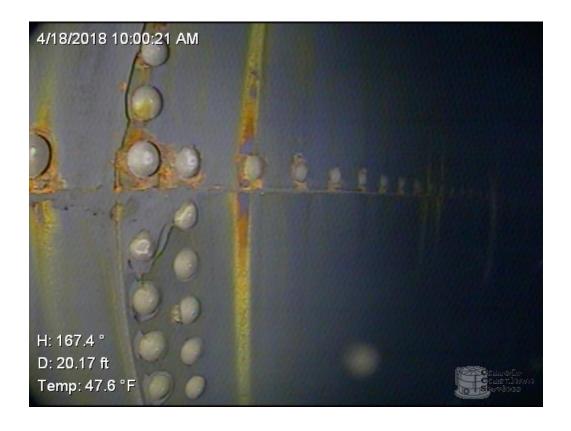
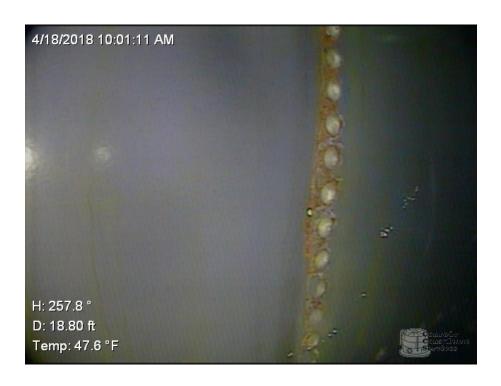
LEAK ON PLATE JOINT

4.	Repair a leak at the 20' water line from the surface
5.

17-18	Roof Exterior & Views From The Roof / LEAK
19-21	Exterior Ladder / Sideshell access
21-22	Overflow pipe
23-24	Upper Access Hatch
25-26	Hardware / Center Vent
27-28	Perimeter Fence
28-29	Inlet / outlet
30-32	Bottom / Shell Manhole
33-40	Interior Sidewalls / leak photo on Page 39
41-42	Interior ceiling
