**Livingston County
Water and Sewer Authority**

**Leicester/York Regional Water Supply
Expansion
Engineering Report Amendment #1**

March 2024

County of Livingston
1 Court Street, Rm B02
Geneseo, NY 14454
RE: 6 Murray Drive
350,000 Gallon EWT
March 4, 2016 & April 12, 2016
Mr. John Driscoll
S.C.S.
(585) 243-7505
Job No. 316029

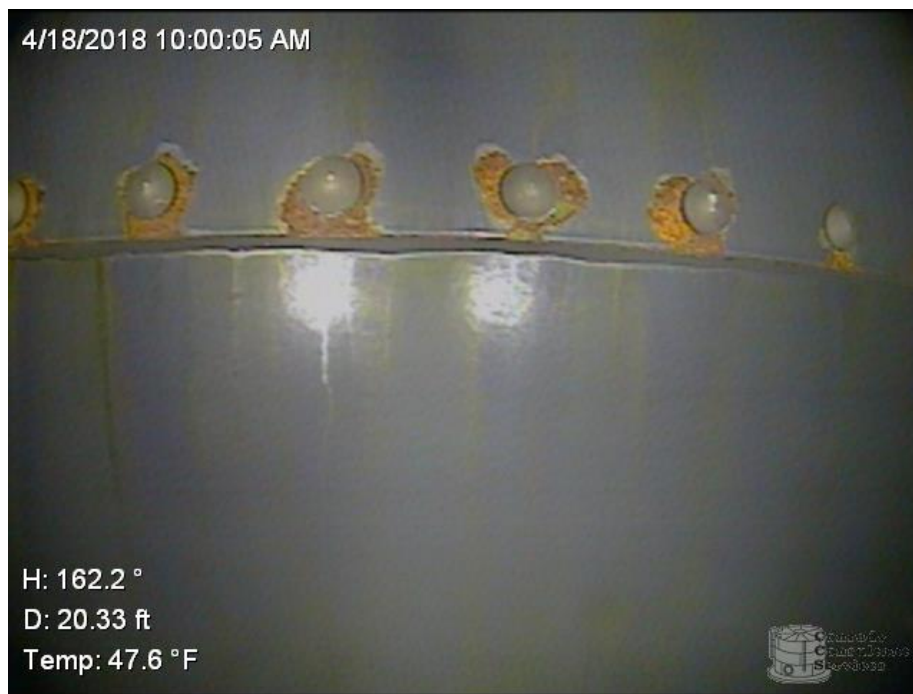
LEAK ON PLATE JOINT

4.	Repair a leak at the 20' water line from the surface
5.
